## WEST VIRGINIA HISTORIC PROPERTY INVENTORY FORM

| <b>Street Address</b><br>Southeast Corner of East Main Street<br>and High Street | <b>Common/Historic Name/Both</b><br><input type="radio"/> <input type="radio"/> <input type="radio"/><br>Pancake Store Building (Historic) /<br>Coffee Cupboard (Common) | <b>Field Survey #</b><br>7 | <b>Site # (SHPO Only)</b><br>HM-0131 |

NAME Romney Commercial Historic District

## 7. Pancake Store Building (late 19<sup>th</sup> century)

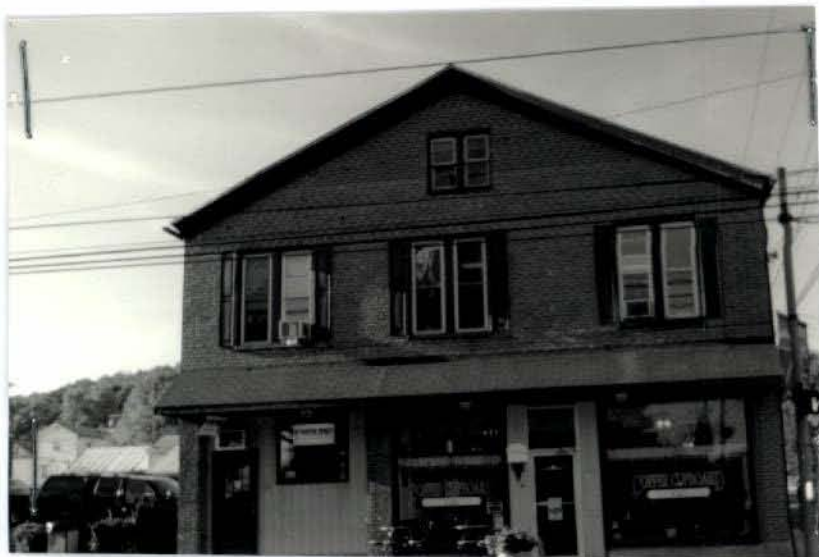
Negative #18A

This is a 2 ½ story, 3-bay, gable-front, brick building with a front façade laid up primarily in 7:1 common bond, machine-made brick. The façade has been sandblasted and shows the deleterious effects of that treatment. The bricks in the upper gable are darker than those below and are laid up in 6:1 common bond. This suggests the building originally displayed a flat roof. Side wall construction features a softer 5:1 common bond brick. First-story side walls are not keyed into the façade and may indicate the façade was entirely rebuilt. The front façade's lower level is dominated by a badly altered, two-part commercial front that is topped by a full-width pent roof. Upper level fenestration consists of three pairs of modern, narrow 1/1 windows, while the gable level is illuminated by an older pair of 1/1 openings. Despite a series of significant alterations, this building, constructed by Mr. I. H. C. Pancake, retains sufficient integrity to warrant designation as a contributing resource.
