# HISTORIC PROPERTIES INVENTORY FORM

1. NAME(S), historic/common: Austin Restaurant

2. LOCATION, street/road: Main Street

## WEST VIRGINIA HISTORIC PROPERTY INVENTORY FORM

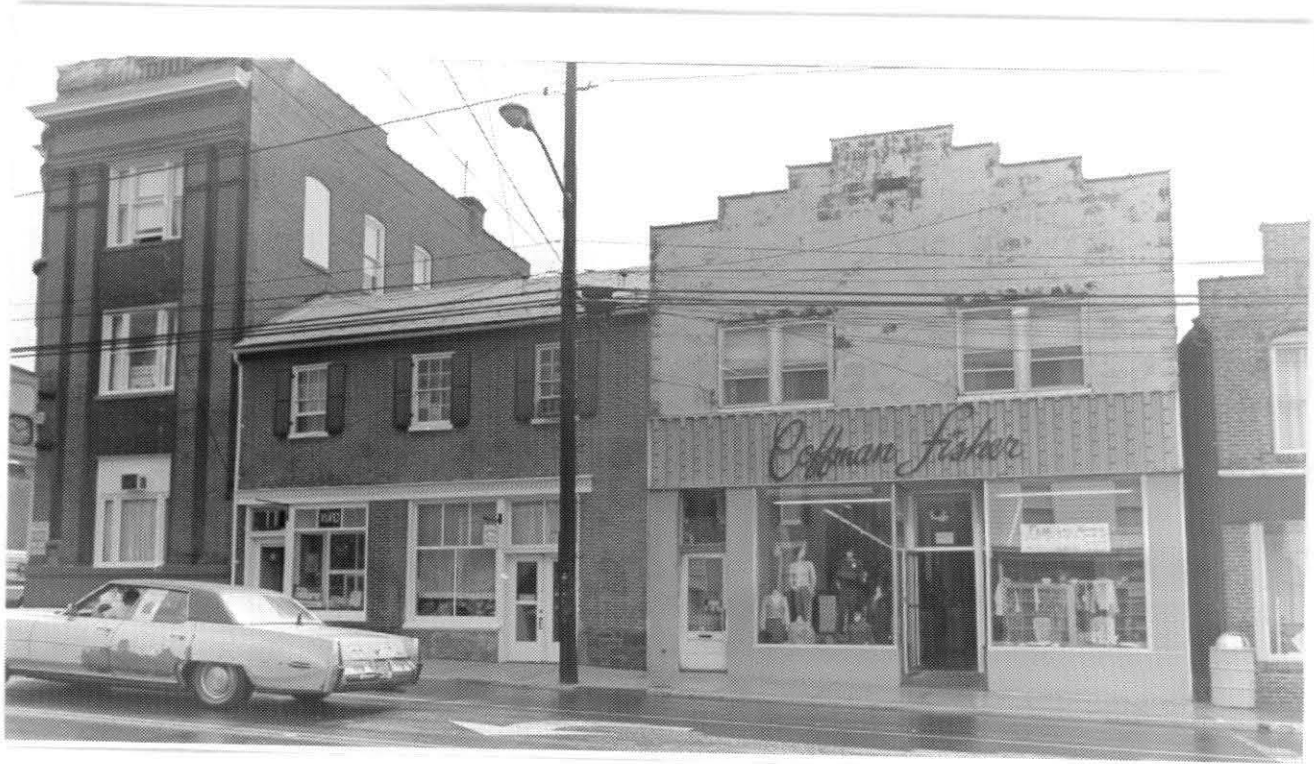
The small two story brick building is constructed using the Flemish bond pattern. Little has been recorded concerning the history of the building, however, local residents can remember when it was Austins Restaurant. Deed references indicate Cornelius A. Austin owned the building in 1922.

Early photographs were not available to determine significant changes in the structure, however, when one examines the Main Street facade it is evident that changes have been made. Two flat arches top the large glass windows in a fashion that is consistent with the upper story fenestration, which had double hung sashes. A dentil band runs the length of the roofline on this facade.

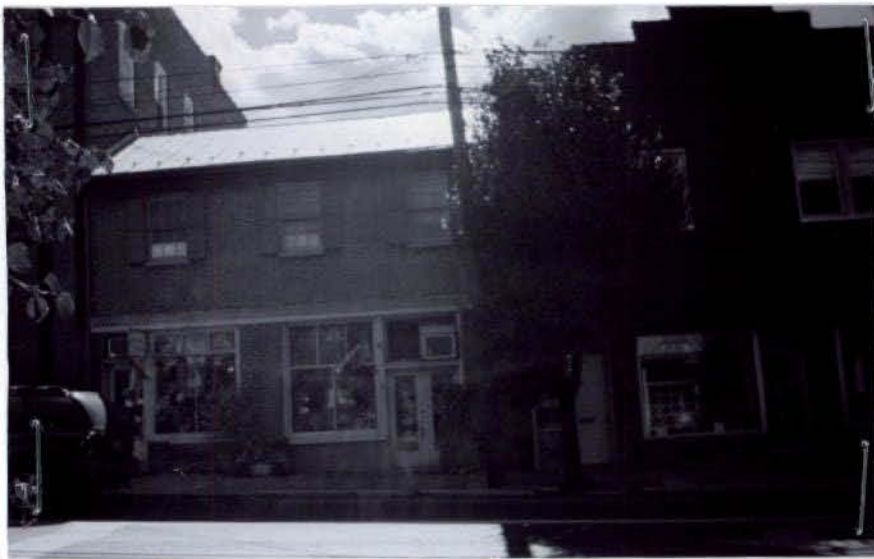
Negative #2

Located immediately adjacent the (Old) First National Bank of Romney, this building's Flemish Bond brick, jackarches, and mouse tooth cornice treatment suggest it is a close contemporary of the c. 1790 Kerns House. The 3-bay building sits on a fieldstone foundation. The low-pitch gable roof is sheathed in standing seam metal. The eaves display very little overhang. Surviving original jackarches indicate the large commercial windows, doors, and nicely dentilated trim work on the lower level are later considerations. These appear to date to the late-19<sup>th</sup> or early-20<sup>th</sup> century. This building is in good condition and contributes to the Romney Commercial Historic District.
