WEST VIRGINIA HISTORIC PROPERTY INVENTORY FORM

HM-0047-0020

NAME Romney Commercial Historic District

37. Northeast corner of East Main Street and Antigo Place (c. 1850)

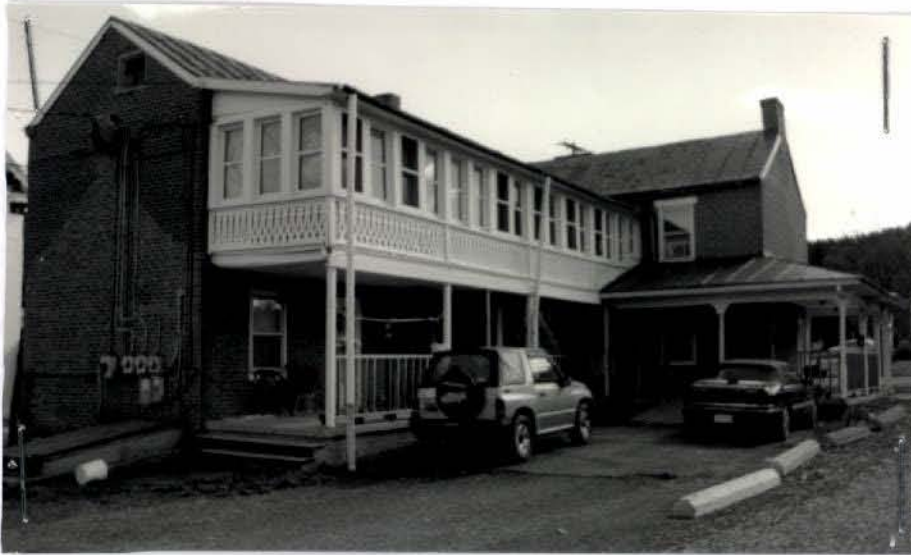
This 2-story, 3-bay, gable-roofed building features 5:1 common bond brick construction. The original front entrance is enclosed and reduced in size and accommodates a window. Wooden lintels and sills accent façade openings. Windows are modern replacements. Standing seam metal covers the roof. Corbelled bricks serve as cornice treatment on both the front and rear walls. Narrow-gauge fascia boards embellish the roofline of the gable ends. Access to the building is through a doorway in the left (west) gable wall. The opening is protected by a hipped-roof porch complete with bracketed capitals. A very long 6:1 common bond brick ell extends from the dwelling's southeast corner. This ell, originally one story in height, was extended to two stories and features a 2nd-story porch. The upper level, possibly a former sleeping porch, has been enclosed and fitted with a continuous bay of windows. This building contributes to the Romney Historic District.
