## WEST VIRGINIA HISTORIC PROPERTY INVENTORY FORM

| <b>Address</b><br>Rt. 220/28 | <b>Common/Historic Name/Both</b><br><div style="display: flex; justify-content: space-around;"> <span>O</span> <span>O</span> <span>O</span> </div> | <b>Field Survey #</b><br>HM-1192 | <b>Site # (SHPO Only)</b><br>HM-0090-0002 |
| <b>Town or Community</b><br>Purgitsville vicinity | <b>County</b><br>Hampshire | <b>Negative No.</b><br>WV_Hampshire<br>County_HM-1192.tif | <b>NR Listed Date</b> |

| <b>Street Address</b><br><u>US</u><br>Route 220 | <b>Common/Historic Name/Both</b><br><input checked="" type="checkbox"/> Structure 2 | <b>Field Survey #</b><br>0002 | <b>Site # (SHPO Only)</b><br>HM-0090-0002 |

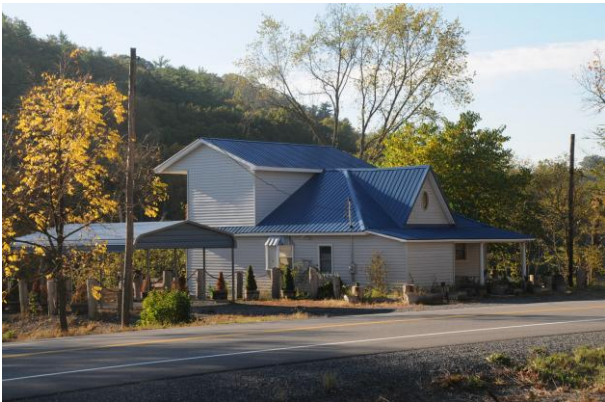
| <b>Description of Building or Site (Original and Present)</b> 2 Stories    ____ 2 ____ Front Bays<br>Large cross-gable house with replacement sliding windows, bay window, raised rear wing.<br><br><i>(Use Continuation Sheets)</i> | | | | | |
| <table style="width: 100%;"> <tr> <td style="width: 15%;"><b>Alterations</b></td> <td style="width: 10%; text-align: center;"> <input checked="checked" type="checkbox"/><br/>Yes </td> <td style="width: 10%; text-align: center;"> <input type="checkbox"/><br/>No </td> <td style="width: 65%;"> If yes, describe    reconfigured footprint, aluminum siding, replacement windows </td> </tr> </table> | | <b>Alterations</b> | <input checked="checked" type="checkbox"/><br>Yes | <input type="checkbox"/><br>No | If yes, describe    reconfigured footprint, aluminum siding, replacement windows |
| <table style="width: 100%;"> <tr> <td style="width: 15%;"><b>Additions</b></td> <td style="width: 10%; text-align: center;"> <input checked="checked" type="checkbox"/><br/>Yes </td> <td style="width: 10%; text-align: center;"> <input type="checkbox"/><br/>No </td> <td style="width: 65%;"> Rear wing </td> </tr> </table> | | <b>Additions</b> | <input checked="checked" type="checkbox"/><br>Yes | <input type="checkbox"/><br>No | Rear wing |
