## WEST VIRGINIA HISTORIC PROPERTY INVENTORY FORM

| <b>Address</b><br>Rt. 220/50 | <b>Common/Historic Name/Both</b><br>x            O            O<br>High house | <b>Field Survey #</b><br>HM-1230 | <b>Site # (SHPO Only)</b><br>HM-0124 |

| <b>Street Address</b><br>intersection US Rt. 220 and US Rt. 220/WV 28 | <b>Common/Historic Name/Both</b><br><input checked="" type="checkbox"/> unknown <input type="checkbox"/> <input type="checkbox"/> | <b>Field Survey #</b><br>HPI #1 | <b>Site # (SHPO Only)</b><br>Hm-024 |
| | <b>Part of What Survey / FR#</b><br>Junction Bridge State No. S314-50-1.58 Fed No. BR 0050(145)E | | |

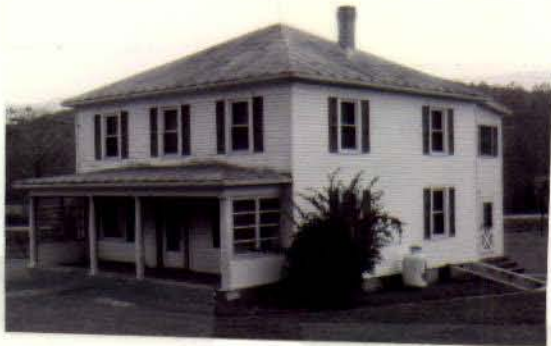
| <b>Description of Buildings or Site (Original and Present)</b><br>The structure is a frame, two-story American Foursquare with a two storyshed roof addition on the back. The main block is three bays wide and two bays deep. The house is clad with drop wood siding and a hipped roof is sheathed in standing seam tin. The windows are moder sash replacements with an additional Bay window added at the rear side. The main entrance is centered on the fron facadeand is covered by a full-width three bay porch. The hipped porch roof rest on four wooden columns and is enclosed at both sides with louved glass windows. There is one interior brick chimney located on the righth slope of the roof | |
| <b>Alterations</b> <input checked="" type="checkbox"/> Yes <input type="checkbox"/> No If yes, describe modern windows and replacement storm doors. | |
| <b>Additions</b> <input checked="" type="checkbox"/> Yes <input type="checkbox"/> No If yes, describe Southern backside has two story room addition with shed roof and ancillary entrance. | |

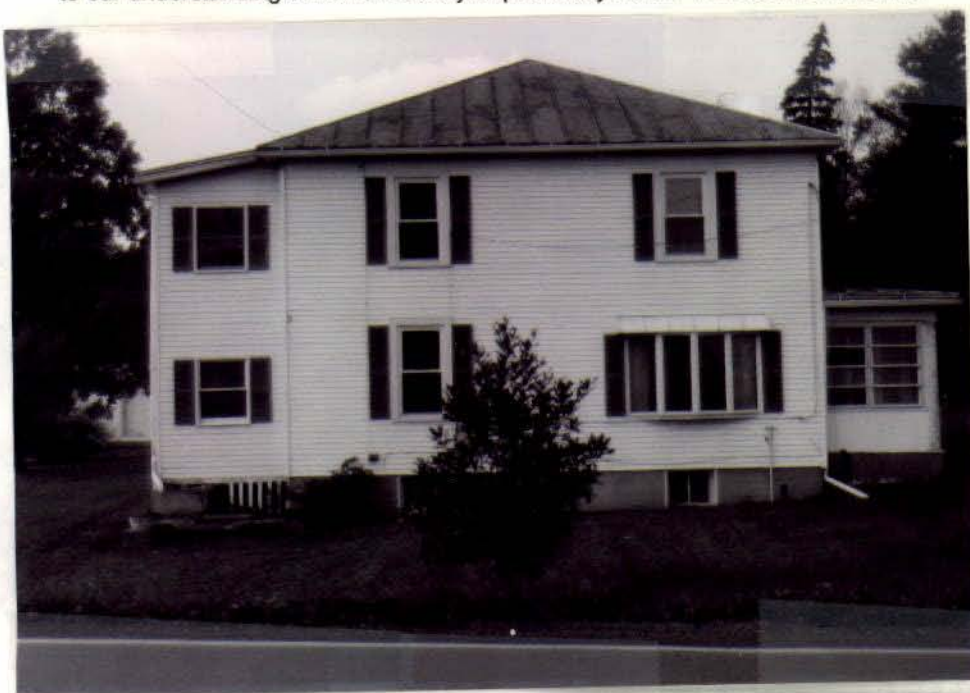
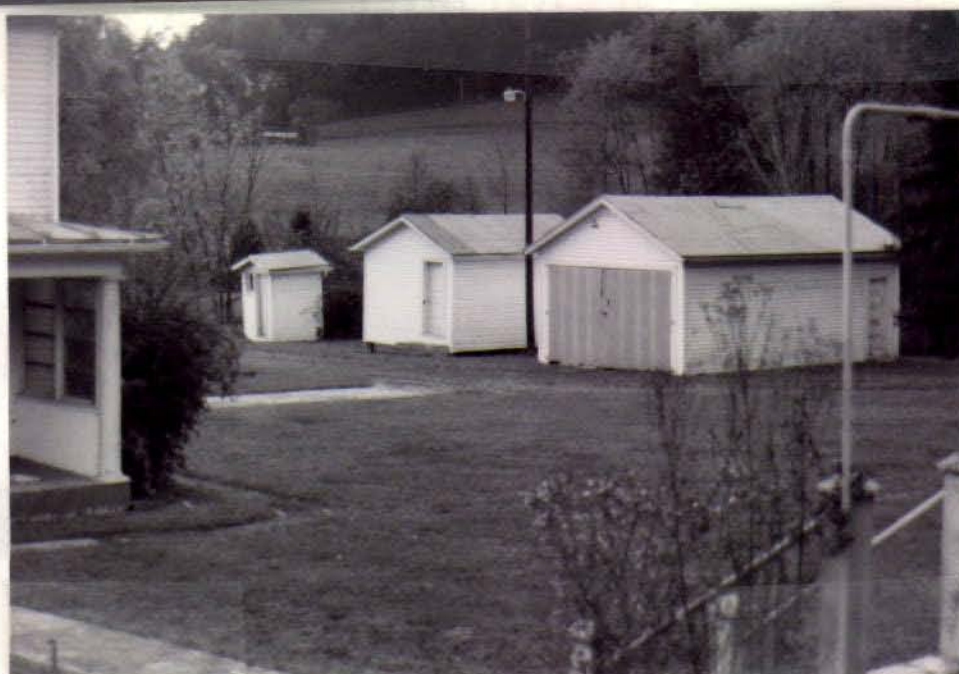
| <b>Describe All Outbuildings</b><br>(3) wooden outbuildings garage, workshop and pump house (see photo). | |
