## WEST VIRGINIA HISTORIC PROPERTY INVENTORY FORM

| <b>Street Address</b><br>54 South Bolton Street | <b>Common/Historic Name/Both</b><br><div style="text-align: center;"> <input type="radio"/>      <input type="radio"/>      <input type="radio"/> </div> Beauty Manor | <b>Field Survey #</b><br>50 | <b>Site # (SHPO Only)</b><br>HM-0182 |

NAME Romney Commercial Historic District

## 50. 54 South Bolton Street (1936)

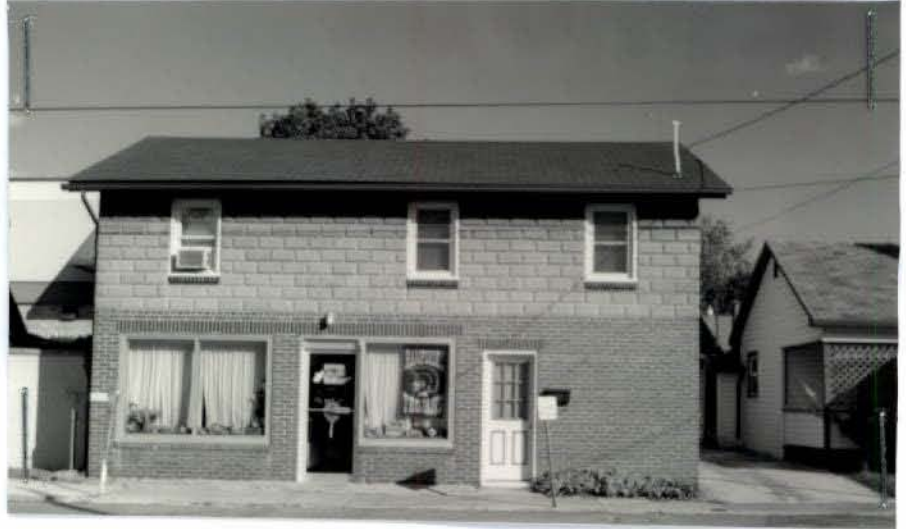
Negative# 16A

The Beauty Manor is a plain but relatively intact Depression-era, mixed-use building. A date stone indicates a 1936 construction date. It is a two stories tall and three bays wide, with a low-pitch, gable roof that is covered with asphalt shingles and broad, overhanging eaves. The masonry walls rest on a slab foundation. The 1<sup>st</sup> story of the front façade is executed in bricks laid in 7:1 common bond. The building's remaining walls are constructed of concrete block designed to imitate ashlar stone. The brick facade is keyed into the blocks. Windows are 1/1 modern replacements, but the openings retain their original brick flat-arches and sills.

The façade's asymmetrical 1<sup>st</sup> story contains two sections. The left (north) side is commercial space and distinguished by plate-glass windows in aluminum frames, and a matching aluminum-and-glass door. A domestic quality door is located on the right side of the commercial area and leads to a second story apartment.

Additions include a rear ell and enclosed rear porch. These are not visible from the public right-of-way. Despite the replacement of windows and doors, this building retains much of its historic character and is a contributing resource to the proposed Romney Commercial Historic District.
