## WEST VIRGINIA HISTORIC PROPERTY INVENTORY FORM

NAME Romney Commercial Historic District

**52. Hampshire County Co-Op, Inc. (c. 1940)**

South Marsham Street

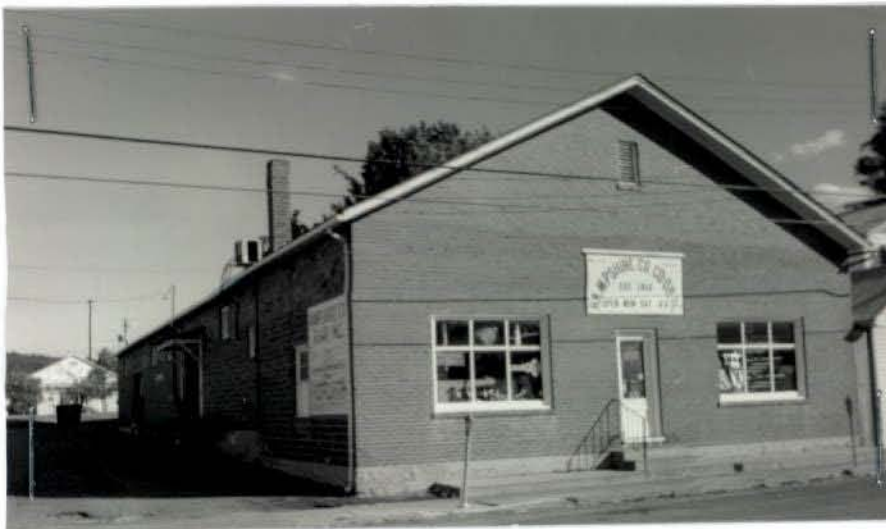
Negative #2

Located immediately adjacent the public right-of-way, the Hampshire County Co-Op, Inc. building is a long, rectangular, 3-bay, gable-front warehouse structure. The low-pitch gable roof displays a slight overhang and open eaves. A tall brick chimney stack pierces the roof on the building's north side. The front façade features 6:1 common bond brick construction, while a hard-fired, terra cotta-like block is used for the side and rear elevations. All walls rest on a poured concrete foundation. Walls display ghost evidence near the roofline that suggesting a halt in construction or a partial rebuild.

The Co-Op's front (west) façade is representative of a mid-20<sup>th</sup> century commercial concern. It currently houses a hardware store. The unembellished center entrance is flanked on either side by a large multi-light, plate-glass window, all of which appear original. The long, north wall contains two raised loading docks. These correspond with sliding doors and provide communication with the building's storage area. One retains its platform and shed-roofed porch hood. Windows consists of a series of small, irregularly spaced, fixed-light windows. In addition, the remains of a 4/4, double-hung sash opening is located near the northwest corner and corresponds with the front office area. A pedestrian entrance is found in the rear (east) wall. Openings on the south side are not visible due to the presence of another building.

The Hampshire County Co-Op warehouse is an exceptional building type. It is an industrial structure in an otherwise commercial/residential area. It is, however, historic, in good condition and significant for its association with regional fruit and agriculture production. It is considered to be a contributing resource. It is the only building on Marsham Street to be considered so.
