## WEST VIRGINIA HISTORIC PROPERTY INVENTORY FORM

| <b>Street Address</b><br>Falling Leaf Road//WV Rt. 9 | <b>Common/Historic Name/Both</b><br><div style="text-align: center;"> <input checked="" type="radio"/>      <input type="radio"/>      <input type="radio"/> </div> Woodrow Union Church | <b>Field Survey #</b><br>HM-0150 | <b>Site # (SHPO Only)</b><br><div style="text-align: center; font-size: 1.2em;">10-012</div> |

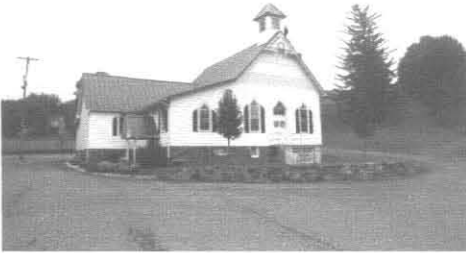
Photograph

| <b>Description of Building or Site (Original and Present)</b> <span style="float: right;">_____ 1 _____ Stories    4 _____ Front Bays</span><br>Metal roof, stone veneer foundation. Gothic windows with decorative stylized shutters. Left side ell extension with second entry. Original 2/2 double hung sash with pointed arch above, Masonry stairs with metal handrails. Snowbirds on roof. Well maintained and updated older church.<br><br><div style="text-align: right;">(Use Continuation Sheets)</div> | |
| <b>Alterations</b> <input checked="checked" type="checkbox"/> Yes <input type="checkbox"/> No    If yes, describe Aluminum siding | |
