## WEST VIRGINIA HISTORIC PROPERTY INVENTORY FORM

| <b>Street Address</b><br>Rt. 29 | <b>Common/Historic Name/Both</b><br><div style="text-align: center;"> <input type="radio"/>      <input type="radio"/>      <input type="radio"/> </div> | <b>Field Survey #</b><br>HM-0570 | <b>Site # (SHPO Only)</b><br><div style="text-align: center; font-family: cursive;">HM-0618</div> |
| <b>Architect/Builder</b> | <b>Date of Construction</b><br>Circa 1880 | <b>Style</b><br>I-House | |

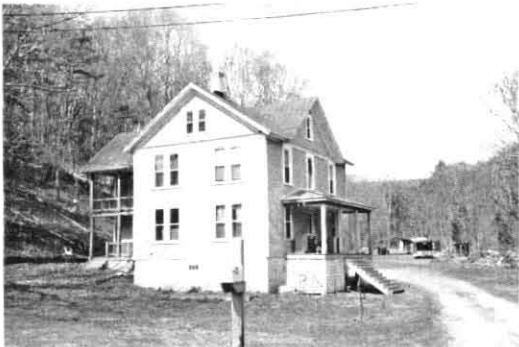
Photograph

| Description of Building or Site (Original and Present) <span style="float: right;">_2 1/2_ Stories    3_ Front Bays</span><br>Large house with bold center front gable, three ranked bays with wide wooden trim. 1/1 double hung sash, center hall, raised porch with four square posts supporting a low hipped roof. Wooden front stairs. Rear extension with stacked porches and spindle railing. Old home undergoing extensive, appropriate restoration. This was the original homestead of a large farm in this area<br><div style="text-align: right;"><i>(Use Continuation Sheets)</i></div> | |
