## WEST VIRGINIA HISTORIC PROPERTY INVENTORY FORM

| <b>Street Address</b><br>U.S. Rt. 50 | <b>Common/Historic Name/Both</b><br><div style="text-align: center;"> <input type="radio"/>      <input type="radio"/>      <input type="radio"/> </div> | <b>Field Survey #</b><br>HM-0730 | <b>Site # (SHPO Only)</b><br><div style="font-family: cursive; font-size: 1.2em;">HM-0778</div> |
| <b>Town or Community</b><br>Augusta | <b>County</b><br>Hampshire | <b>Negative No.</b><br>WV_Hampshire County_HM-0730.tif | <b>NR Listed Date</b> |

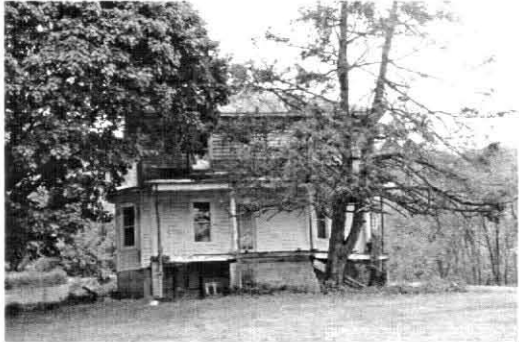
Photograph

| Description of Building or Site (Original and Present) _____ 2_ Stories 3_ Front Bays<br>Low pitch pyramidal roof with center brick chimney. Three front bays, center hall, 1/1 original double hung sash.<br>Three light bay window on left face of the house. Low hipped front porch roof is supported by columns and pilasters with Doric capitals. Porch is being rebuilt. | |
| Alterations <input checked="" type="checkbox"/> Yes <input type="checkbox"/> No     If yes, describe siding | |
