## WEST VIRGINIA HISTORIC PROPERTY INVENTORY FORM

| <b>Street Address</b><br>U.S. Rt. 50 | <b>Common/Historic Name/Both</b><br><div style="text-align: center;"> <input type="radio"/>      <input type="radio"/>      <input type="radio"/> </div> | <b>Field Survey #</b><br>HM-0734 | <b>Site # (SHPO Only)</b><br><div style="font-family: cursive; font-size: 1.2em;">HM-0782</div> | |
| <b>Town or Community</b><br>Augusta | <b>County</b><br>Hampshire | <b>Negative No.</b><br>WV_Hampshire County_0734.tif | <b>NR Listed Date</b> | |
| <b>Architect/Builder</b> | <b>Date of Construction</b><br>Circa 1870 | <b>Style</b><br>Italianate | | |

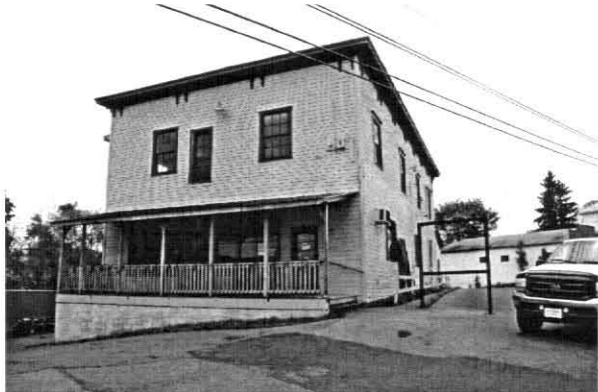
Photograph

| Description of Building or Site (Original and Present) <span style="float: right;">__2__ Stories    __2__ Front Bay</span><br><br>Center hall with fixed pane display windows flush with façade. Transom over the door. Additional side door on the right. Second story features a center hall and 6/6 original double hung sash. Bold roof brackets arrayed in pairs support a deep roof overhang. Windows feature bold lintels of milled wood. Large paved parking lot. | |
| Alterations <input checked="" type="checkbox"/> <input type="checkbox"/> If yes, describe    right face window has been altered in size<br><div style="display: flex; justify-content: space-around; width: 100%;"> <span>Yes</span> <span>No</span> </div> | |
