## WEST VIRGINIA HISTORIC PROPERTY INVENTORY FORM

| <b>Street Address</b><br>W side Harmison Road,<br>c. .1 mi. SW of Augusta | <b>Common/Historic<br/>Property Name/<br/>Both</b> | <b>Field Survey #</b><br>Central Hampshire County<br>Survey No. 43 | <b>Site # (SHPO Only)</b><br><br>Hm-0847 |

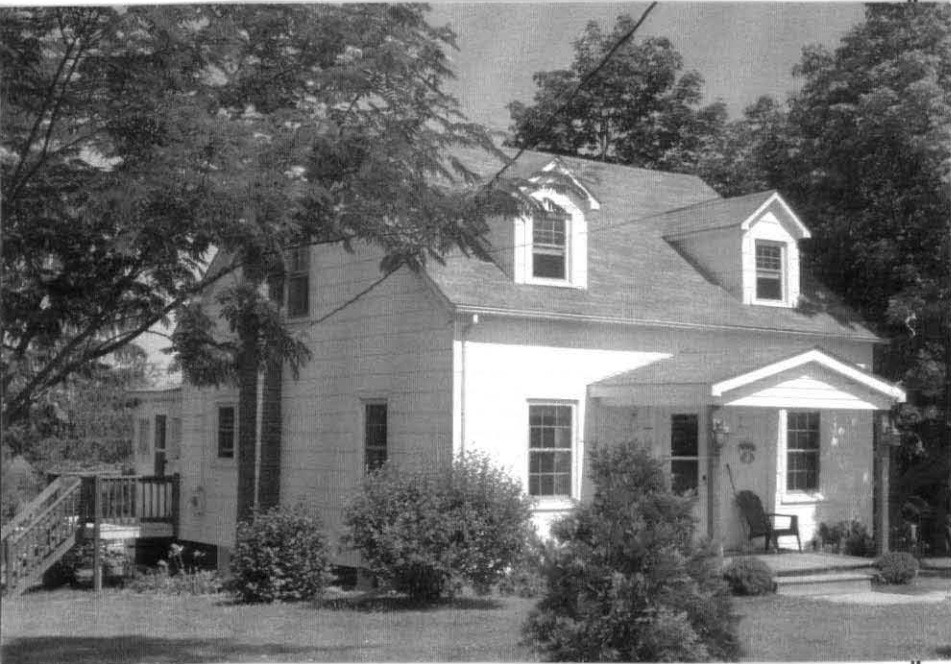
| 1½-story Cape Cod-style residence of wood construction, with a side gable roof and paired gable dormers on the façade. The first story is 3 bays in width, with the centered entrance which is shielded by a pedimented portico supported by plain wood posts. A 1-story addition or enclosed porch is on the rear. Fenestration is flat topped, 6/6, with replacement wood sash. A non-historic wood deck has been built onto the rear. | | | | | | | | | |
| <b>Alterations</b> | <input checked="" type="checkbox"/> Yes <input type="checkbox"/> No | <b>If yes, describe</b><br>Asbestos shingle siding; replacement sash | | | | | | | |
| <b>Additions</b> | <input checked="" type="checkbox"/> Yes <input type="checkbox"/> No | <b>If yes, describe</b><br>Deck on rear | | | | | | | |
