## WEST VIRGINIA HISTORIC PROPERTY INVENTORY FORM

| <b>Street Address</b><br>W side S. of Little<br>Capon Rd., c. 1.4 mi. S<br>of US Rt. 50 | <b>Common/Historic<br/>Property Name/<br/>Both</b> | <b>Field Survey #</b><br>Central Hampshire County<br>Survey No. 64 | <b>Site # (SHPO Only)</b><br><br>HM-0868 |

Central Hampshire County Historic Resource Survey, 2009

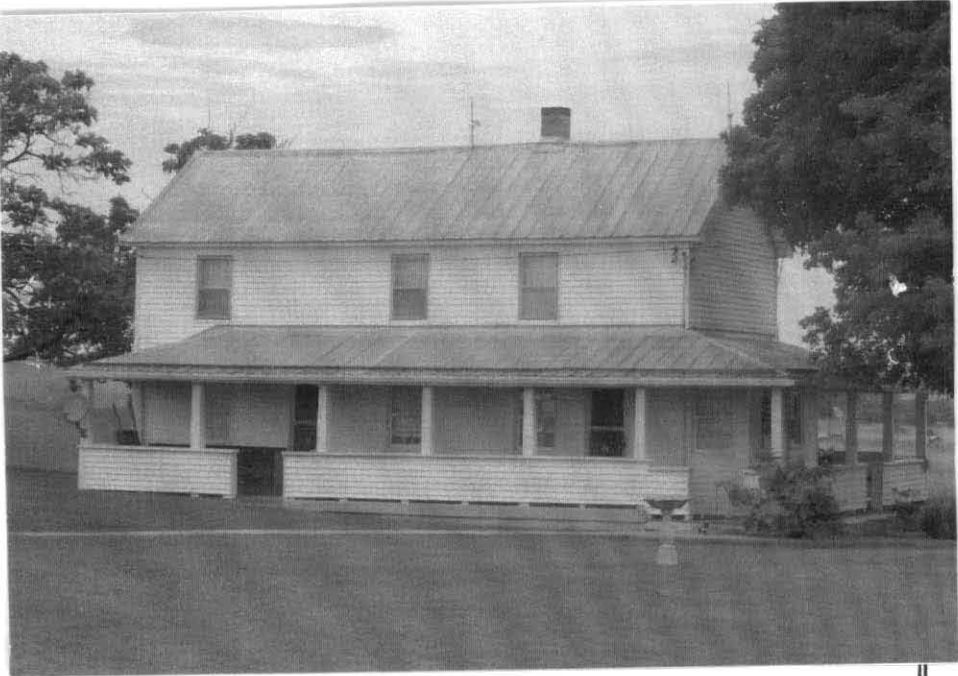
| 2-story vernacular residential building of wood construction, with a side-gable roof and an offset brick chimney penetrating the ridgeline of the roof, suggesting that the building may have been erected in stages. The first story incorporates a 6-bay arrangement, with a wrap-around hipped-roof veranda supported by wood posts and enclosed within a solid balustrade. Fenestration is flat topped, with multi-light sash, no other notable ornament. | | | | | | | | | |
| <table style="width: 100%; border: none;"> <tr> <td style="width: 15%;"><b>Alterations</b></td> <td style="width: 10%;"> <input checked="" type="checkbox"/> Yes    <input type="checkbox"/> No </td> <td style="width: 75%;"> <b>If yes, describe</b><br/> Non-historic siding </td> </tr> </table> | | <b>Alterations</b> | <input checked="" type="checkbox"/> Yes <input type="checkbox"/> No | <b>If yes, describe</b><br>Non-historic siding | | | | | |
| <b>Additions</b> | <input checked="" type="checkbox"/> Yes <input type="checkbox"/> No | <b>If yes, describe</b><br>It appears that a 1-story addition has been erected on one gable end, shielded by the roof of the veranda. | | | | | | | |
