## WEST VIRGINIA HISTORIC PROPERTY INVENTORY FORM

| <b>Street Address</b><br>E side Ben Saville<br>Road, N of Kirby | <b>Common/Historic<br/>Property Name/<br/>Both</b> | <b>Field Survey #</b><br>Central Hampshire County<br>Survey No. 81 | <b>Site # (SHPO Only)</b><br><br>HM-0885 |

Central Hampshire County Historic Resource Survey, 2009

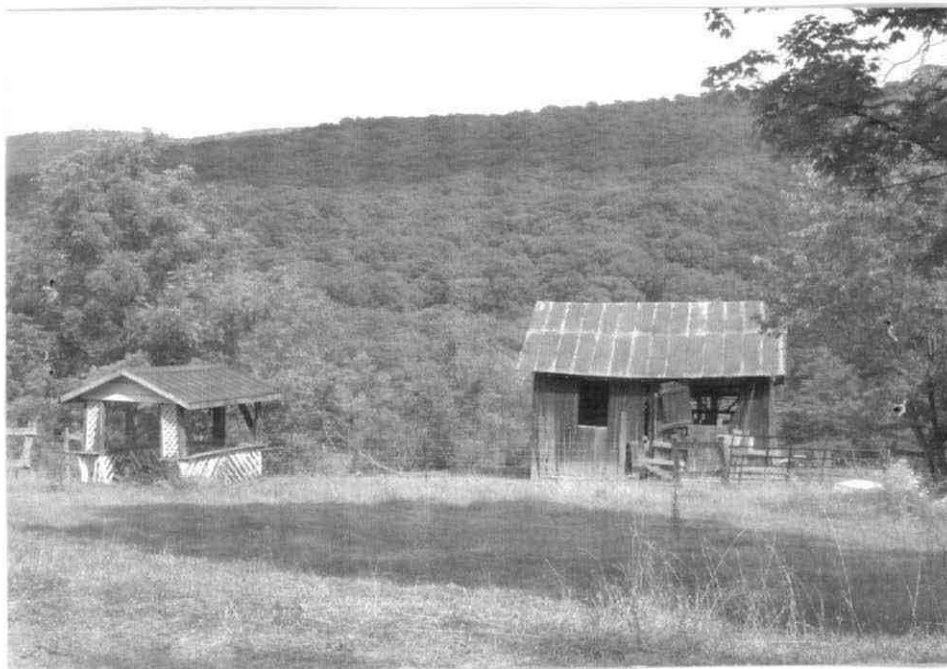
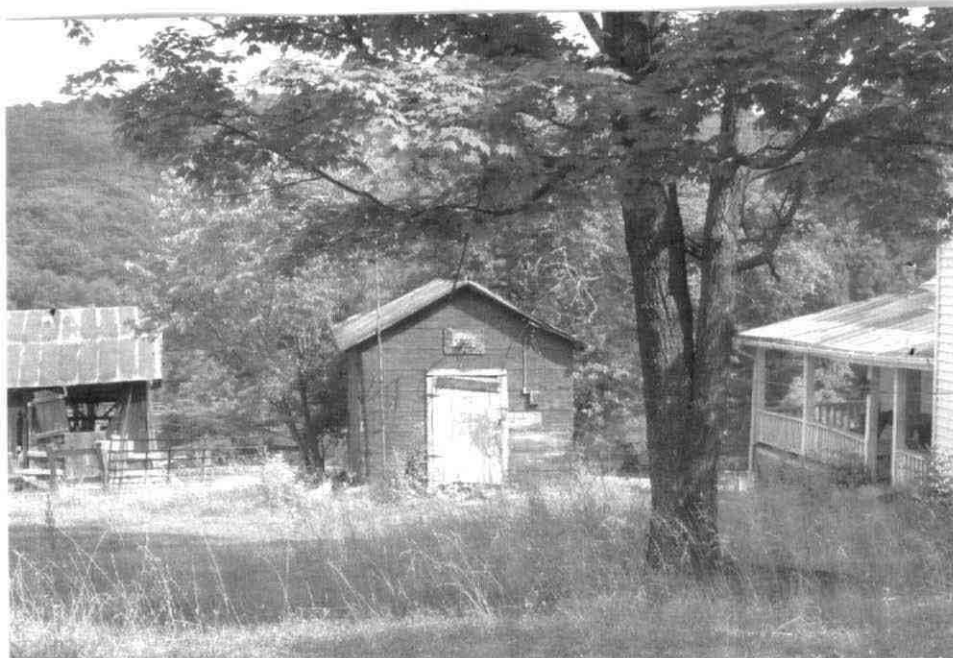
81

2-story central passage I-house of wood construction, with a side-gable roof and a double-gallery shed-roofed porch on the façade. The porch incorporates the original supports on the second story, but those of the first story and all of the balustrade have been replaced. A hipped-roof rear porch, with historic supports and balustrade. 3-bay façade on the main portion of the house, with some 2/2 sash remaining. Matching centered entries on both the first and second story open onto the porch.

Scattered around the property are a series of wood dependencies, some finished in vertical siding and one finished in insul-brick.
