## WEST VIRGINIA HISTORIC PROPERTY INVENTORY FORM

| <b>Street Address</b><br><br>SW cor. Grassy Lick Road and 10/6 | <b>Common/Historic Property Name/Both</b> | <b>Field Survey #</b><br><br>Central Hampshire County<br>Survey No. 84 | <b>Site # (SHPO Only)</b><br><br>HM-0888 |
| <b>Town or Community</b><br><br>Kirby | <b>County</b><br><br>Hampshire | <b>Image No.</b><br>3376 | <b>NR Listed Date</b><br>n/a |

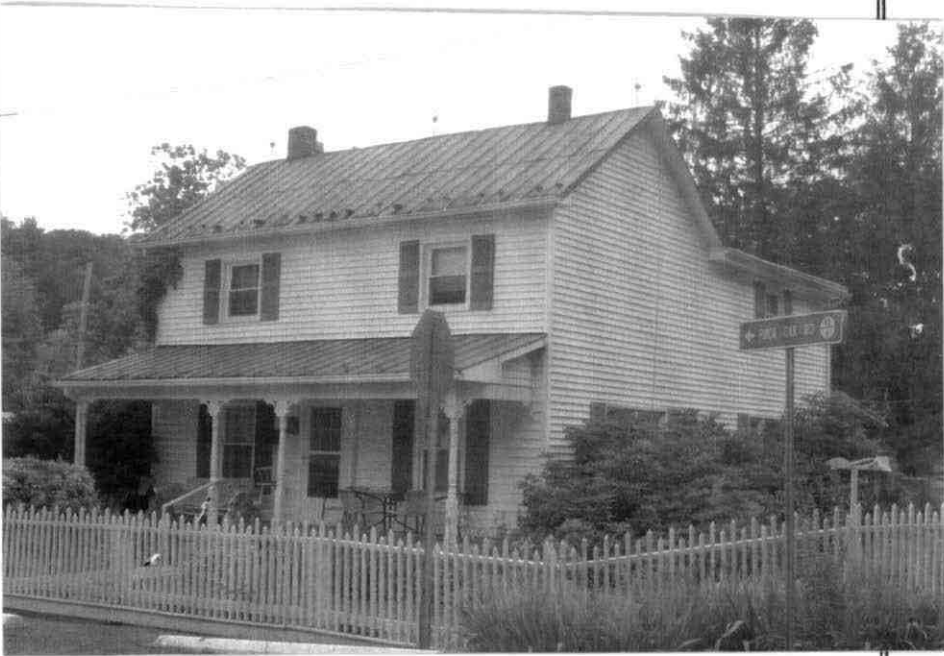
| <p>2-story central-passage I-house of wood construction, with a rearward-projecting ell, and an intersecting gable roof. The main portion of the house is roofed with a side gable roof penetrated by 2 red brick chimneys. 3-bay first story façade with a centered entrance, 2-bay upper-story façade, extending across the façade is a shed-roofed porch, supported by turned Eastlake-style posts ornamented with small sawn brackets. Fenestration is flat topped, with fixed exterior shutters.</p> | |
| <input checked="checked" type="checkbox"/> Yes<br><input type="checkbox"/> No | <b>If yes, describe</b><br>Non-historic siding |
| <p>This house is architecturally undistinguished, has been altered with non-historic siding and window replacements, and does not appear to meet National Register Criteria for Evaluation</p> | |
