## WEST VIRGINIA HISTORIC PROPERTY INVENTORY FORM

| <b>Street Address</b><br>W side Rock Oak Road<br>c. .1 mi. S of Grassy<br>Lick Road | <b>Common/Historic<br/>Property Name/<br/>Both</b><br>Bethel Baptist<br>Church (historic) | <b>Field Survey #</b><br>Central Hampshire County<br>Survey No. 86 | <b>Site # (SHPO Only)</b><br><br>Hm-0890 |

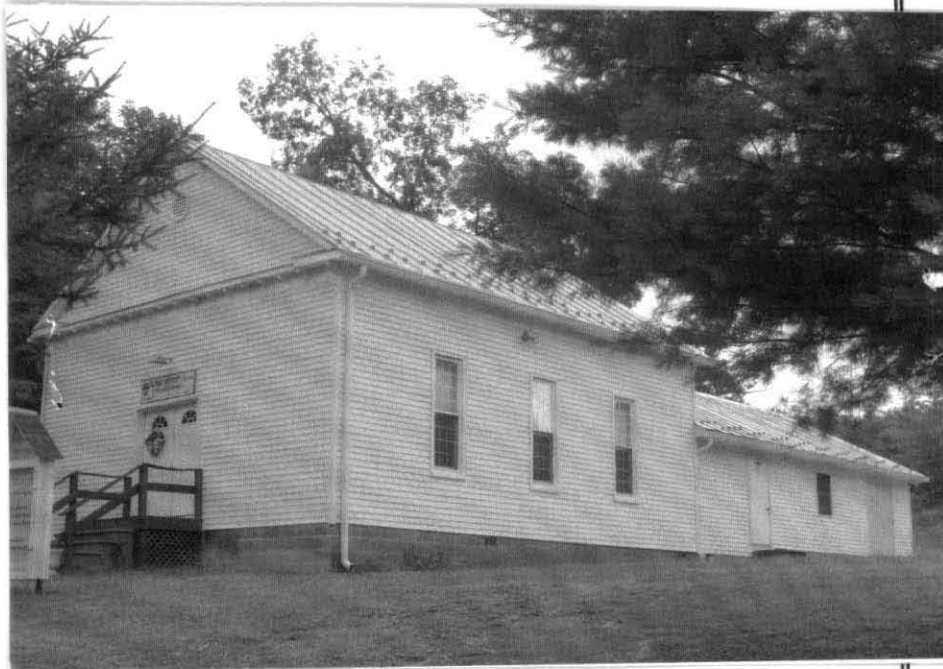
| <p>1-story religious building of wood construction with a temple-form façade, incorporating a centered double door accessed from a non-historic wood stoop. Full return of the cornice on the façade, with modillions under the eaves. 3-bay side elevations with flat topped windows and multi-light replacement sash. A 1-story gable-end oriented addition has been built on the rear.</p> | |
| <b>Alterations</b> | <input checked="" type="checkbox"/> Yes <input type="checkbox"/> No <b>If yes, describe</b><br>Non-historic siding; replacement windows; foundation replaced |
| <b>Additions</b> | <input checked="" type="checkbox"/> Yes <input type="checkbox"/> No <b>If yes, describe</b><br>A non-historic addition has been built onto the rear elevation. |

| <p>This church has been altered with non-historic siding and window replacements, and does not appear to meet National Register Criteria for Evaluation</p> | |
