## WEST VIRGINIA HISTORIC PROPERTY INVENTORY FORM

| <b>Street Address</b><br>W side Rock Oak Road,<br>c. 1 mi. S of Kirby | <b>Common/Historic<br/>Property Name/<br/>Both</b> | <b>Field Survey #</b><br>Central Hampshire County<br>Survey No. 89 | <b>Site # (SHPO Only)</b><br>HM-0893 |

Central Hampshire County Historic Resource Survey, 2009

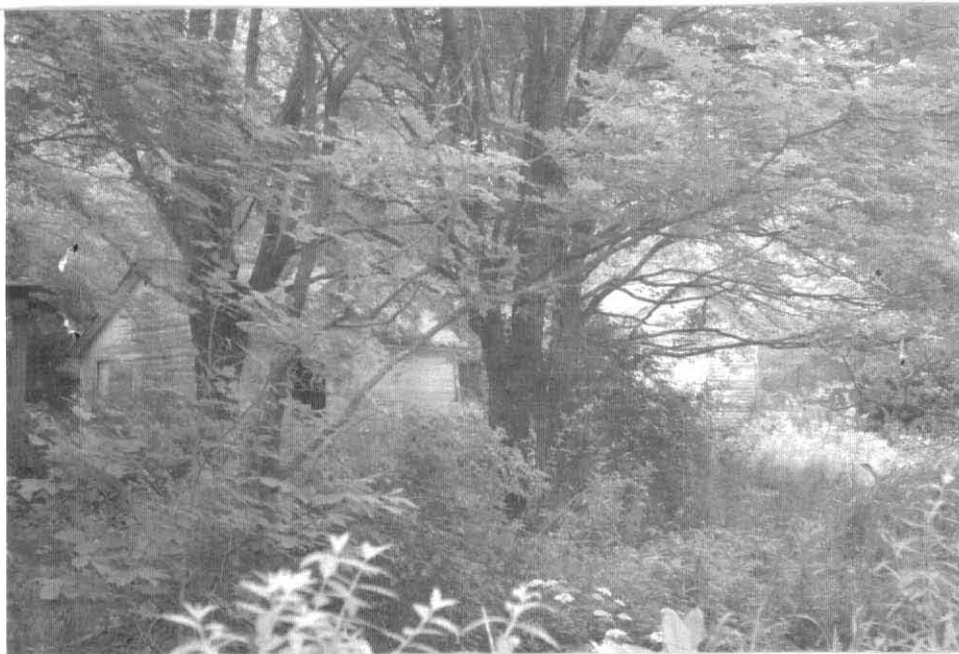
89

| <div style="text-align: right;">2 Stories      3 Front Bays</div> 2-story American Foursquare of wood construction, vacant and badly deteriorated, with a 2-bay façade and a hipped-roof porch supported by Doric columns. Exterior surfaces are finished in thin shiplap siding. Fenestration is flat topped, without notable ornament. <div style="text-align: right;">(Use Continuation Sheets)</div> | |
| Adjacent to the house on a significantly overgrown lot are 2 wood frame dependencies of indeterminate age and usage. <div style="text-align: right;">(Use Continuation Sheets)</div> | |
