## WEST VIRGINIA HISTORIC PROPERTY INVENTORY FORM

| <b>Street Address</b><br>W side Grassy Lick<br>Road, c. 1 mi. N of Kirby | <b>Common/Historic<br/>Property Name/<br/>Both</b><br>Hott's Chapel<br>(common) | <b>Field Survey #</b><br>Central Hampshire County<br>Survey No. 93 | <b>Site # (SHPO Only)</b><br><br>HM-0897 |

Central Hampshire County Historic Resource Survey, 2009

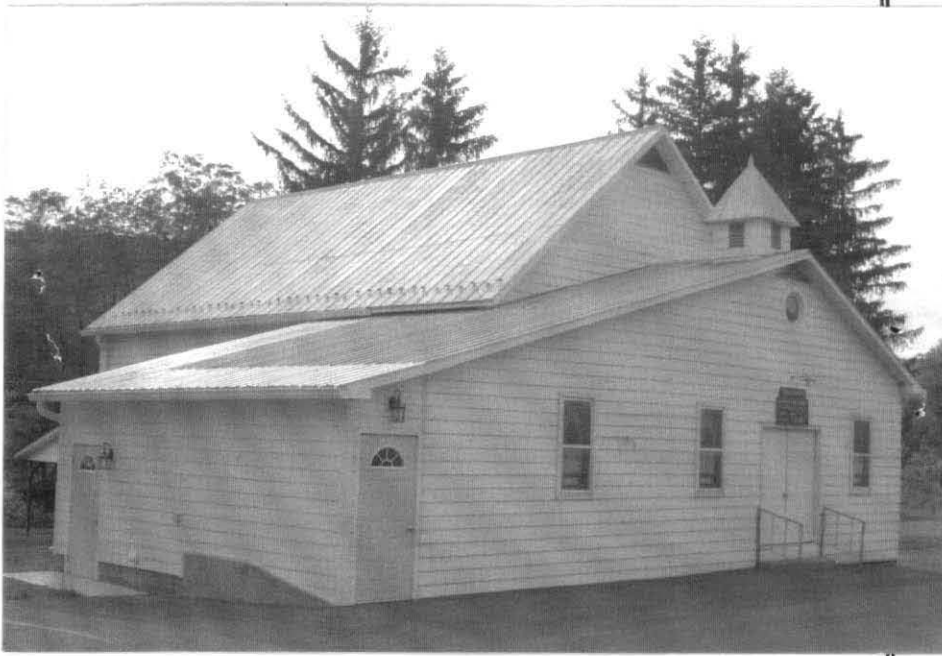
| <p>This is a rural vernacular religious building of wood construction, finished in non-historic siding, and what appear to be several additions. Originally Gothic Revival in character, historic side windows retain their lancet-arched form with religious art glass.</p> | |
| <input checked="" type="checkbox"/> <b>Yes</b><br><input type="checkbox"/> <b>No</b> | <b>If yes, describe</b><br>Non-historic siding |
| <input checked="" type="checkbox"/> <b>Yes</b><br><input type="checkbox"/> <b>No</b> | <b>If yes, describe</b><br>Additions on the façade. |
