## WEST VIRGINIA HISTORIC PROPERTY INVENTORY FORM

| <b>Street Address</b><br>E side Horn Camp Road, c/ 1.6 mi. S of Grassy Lick Road | <b>Common/Historic Property Name/ Both</b> | <b>Field Survey #</b><br>Central Hampshire County Survey No. 198 | <b>Site # (SHPO Only)</b><br><i>HM-0998</i> |

Central Hampshire County Historic Resource Survey, 2009

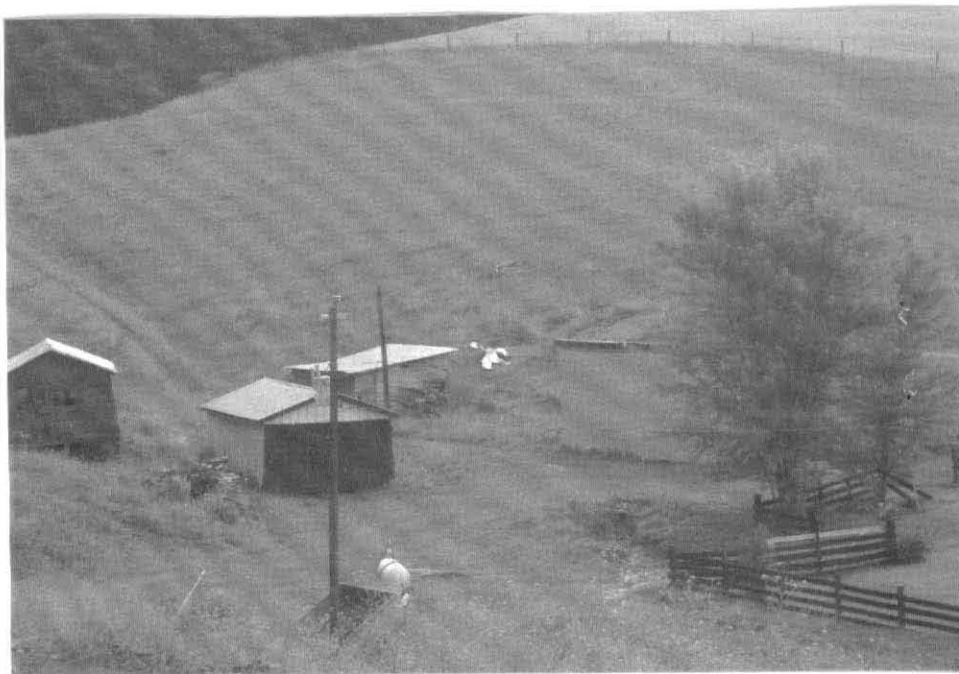
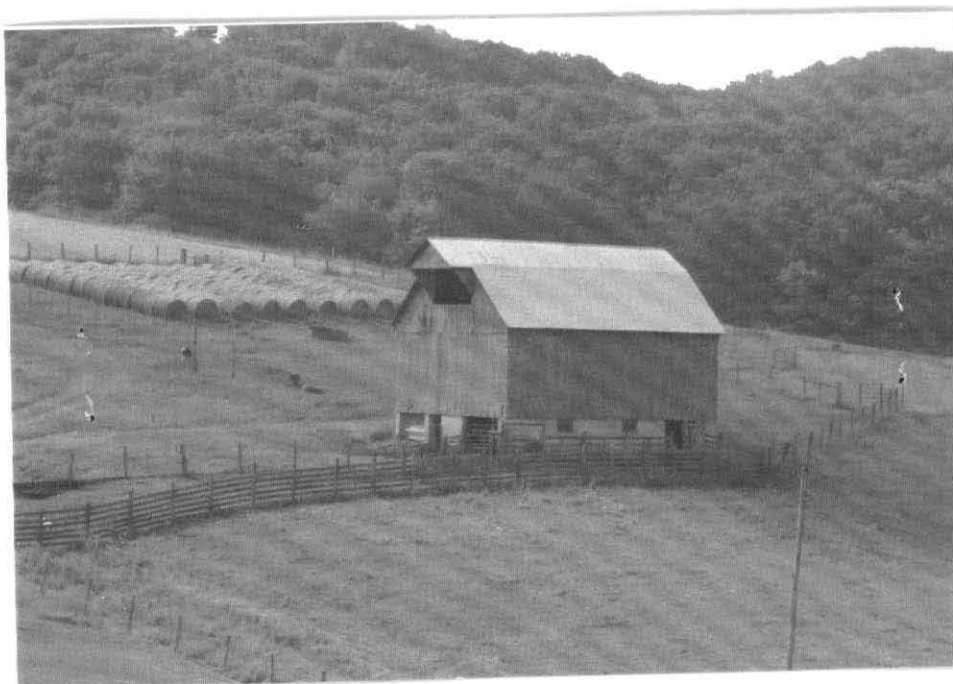
198

| 1 1/2-story vernacular residence of wood construction with a side-gable roof which is penetrated by paired dormers and extends over an original front porch which has been enclosed with a series of operable windows. Fenestration is flat-topped, without notable ornament. "No Trespassing" signage precludes close investigation. | |
| A substantial gambrel roof barn with an extended gable is extended approximately 300 yards behind the house. Other smaller-scale agricultural dependencies are scattered nearby. | |
