## WEST VIRGINIA HISTORIC PROPERTY INVENTORY FORM

| <b>Street Address</b><br><br>E side Horn Camp Road, N of Briar Lick Road | <b>Common/Historic Property Name/ Both</b> | <b>Field Survey #</b><br><br>Central Hampshire County<br>Survey No. 199 | <b>Site # (SHPO Only)</b><br><br>HM-0999 |

Central Hampshire County Historic Resource Survey, 2009

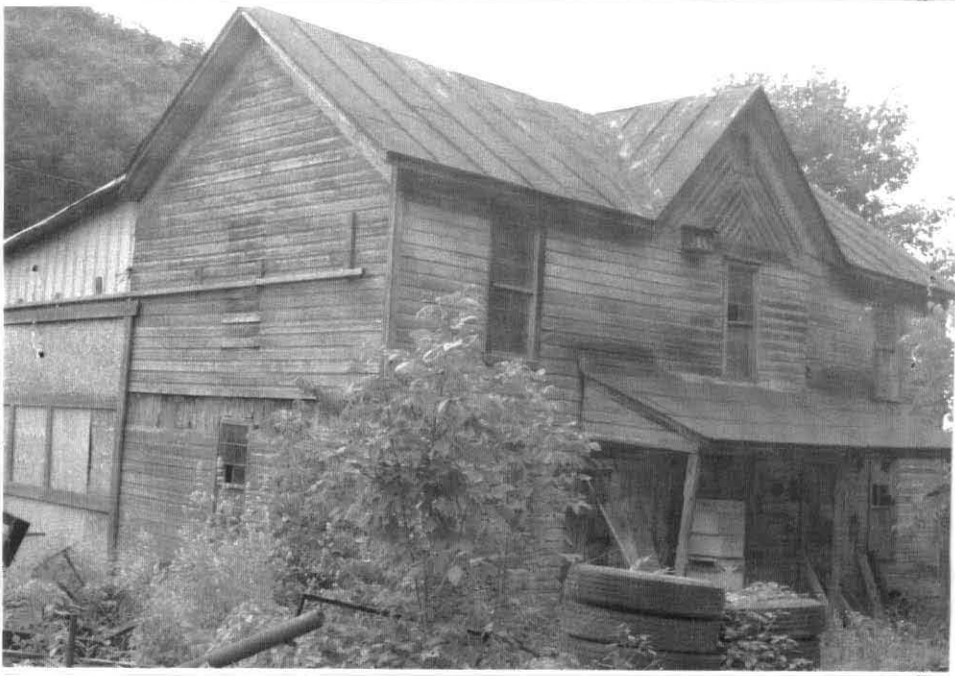
| 2-story vernacular residence of wood construction, with a side-gable roof and a locally distinctive centered pediment on the façade. L-shaped in plan, a non-historic addition has been built in the angle of the ell in the rear. Original exterior surfaces are finished in German siding and are penetrated by 6/6 windows on the façade. The center gable on the façade is finished in diagonal siding, with a pointed-arched window in the pediment. Extending across the façade is a shed-roofed porch, supported by turned posts. Building is deteriorated and appears vacant. | |
| <b>Alterations</b> <input checked="" type="checkbox"/> Yes <input type="checkbox"/> No <b>If yes, describe Deterioration</b> | |
| <b>Additions</b> <input checked="" type="checkbox"/> Yes <input type="checkbox"/> No <b>If yes, describe As noted above</b> | |

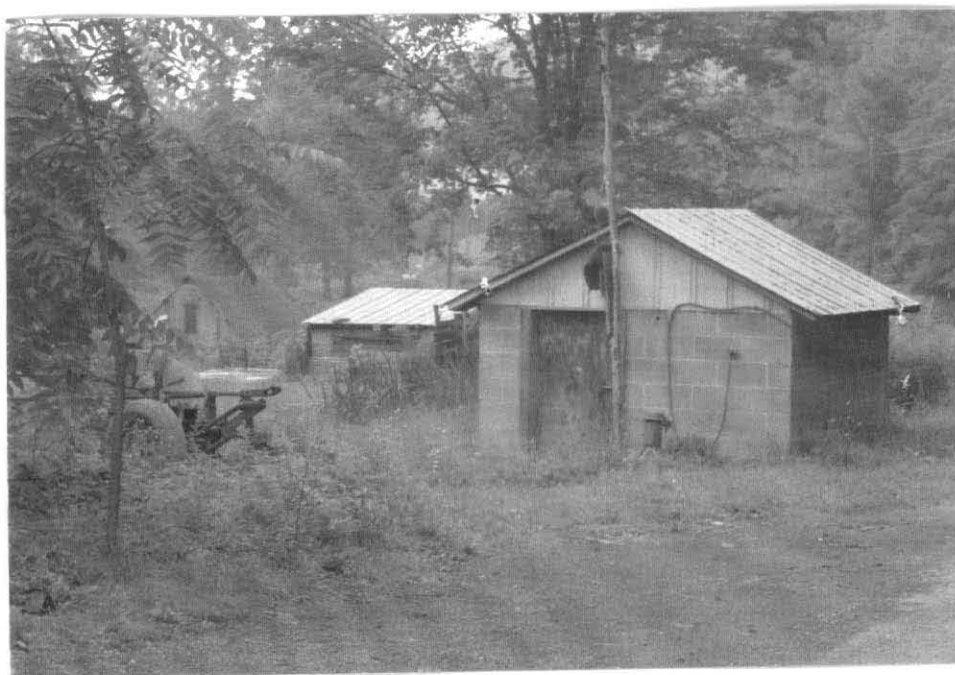
NAME \_\_\_\_\_ Survey Site Number 199

| Associated with the property are a series of domestic outbuildings of concrete block and wood construction, roofed with gable roofs and shed roofs. | |
