## WEST VIRGINIA HISTORIC PROPERTY INVENTORY FORM

| <b>Street Address</b><br>S side Horn Camp Road | <b>Common/Historic Property Name/ Both</b> | <b>Field Survey #</b><br>Central Hampshire County<br>Survey No. 203 | <b>Site # (SHPO Only)</b><br><br>HM-1003 |

Central Hampshire County Historic Resource Survey, 2009

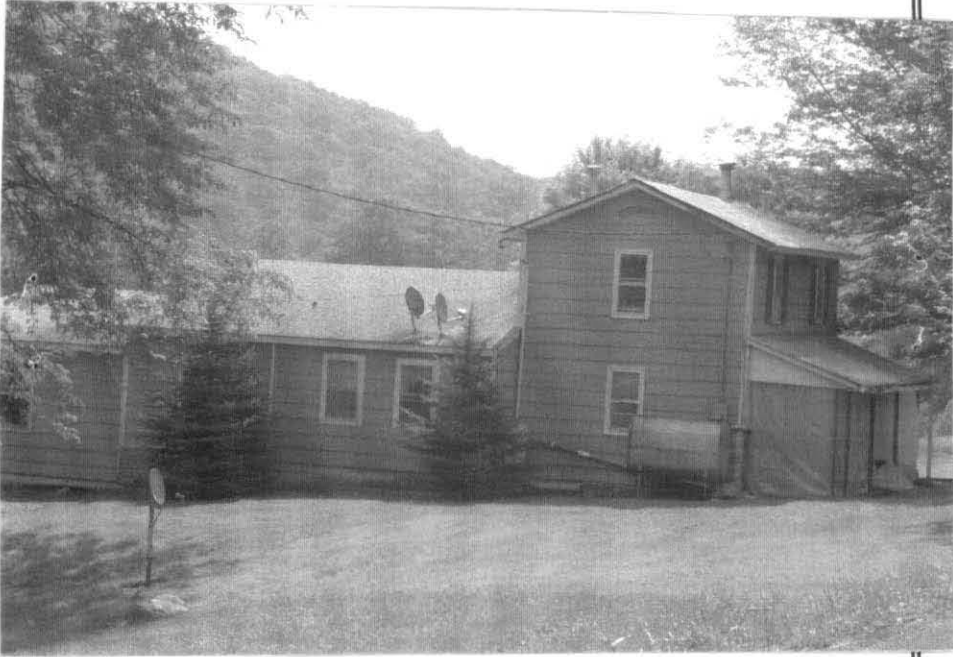
2 Stories 3 Front Bays

2-story vernacular residence of wood construction, with a side-gable roof and several gable-roofed additions at the rear of indeterminate age. Second story of the façade is two bays in width, and the first story is shielded by a shed-roofed porch wrapped in heavy plastic which precludes examination. Fenestration is flat-topped, without notable ornament, with 2/2, 1/1, and 6/6 sash. A modern open deck has been built on one gable end.

several additions and modern deck.

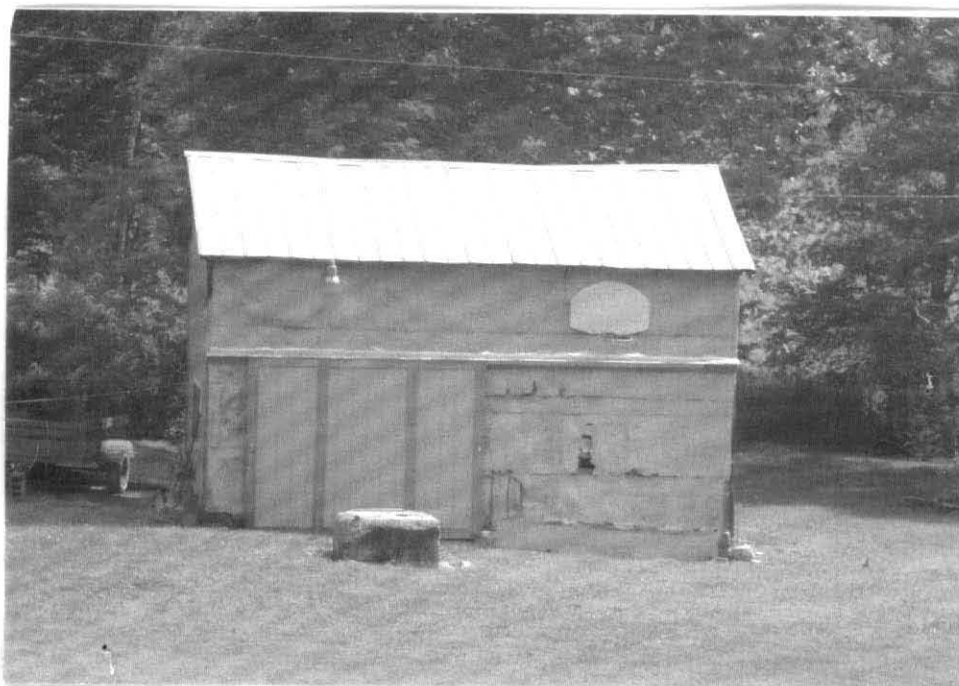
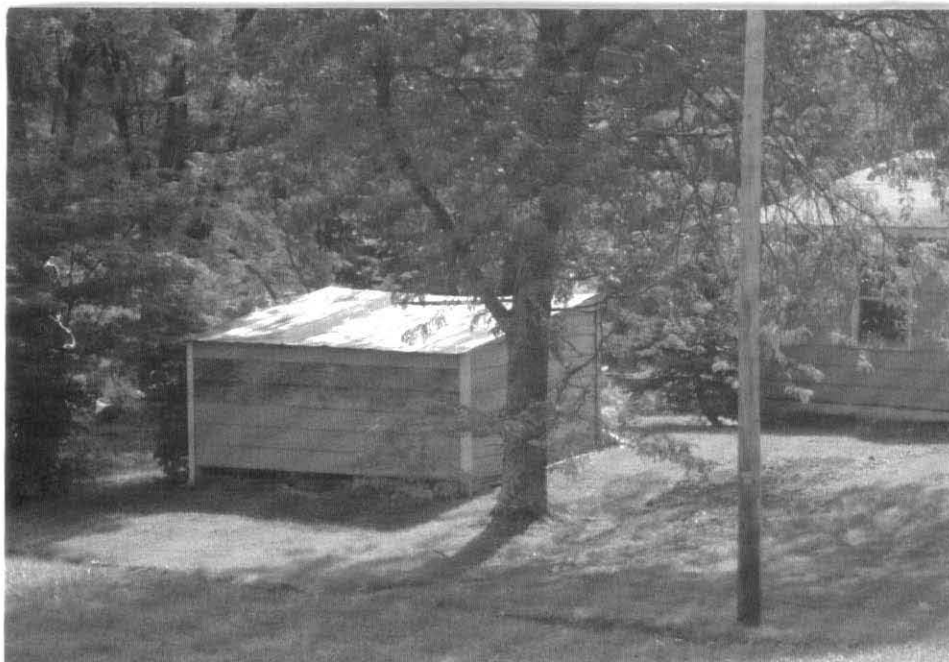
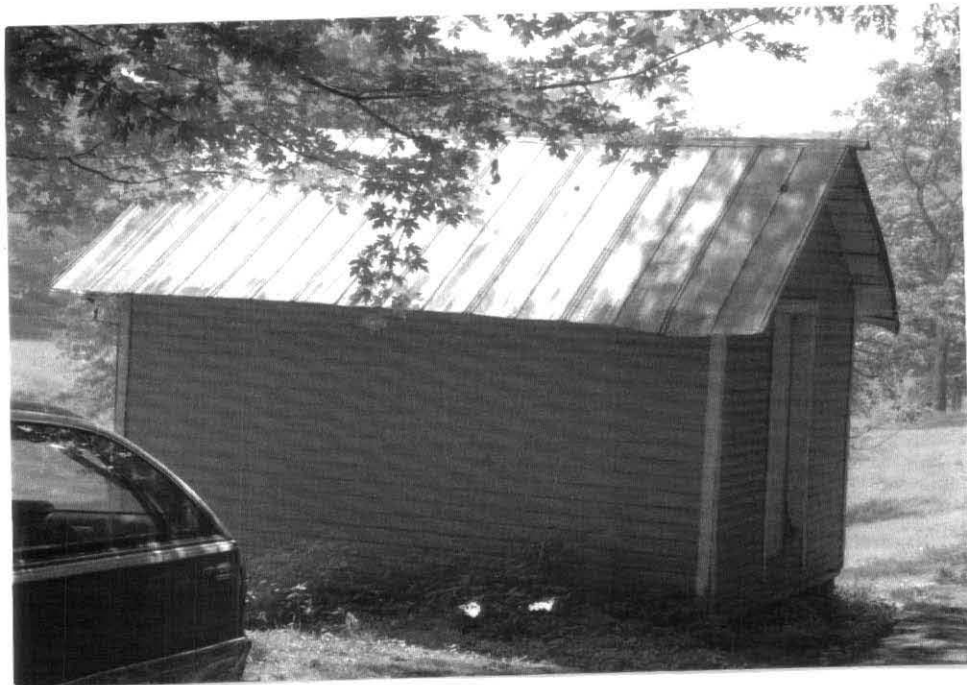
*203*

Associated with the property are several domestic outbuildings of wood construction, typically finished in wood with metal roofs.
