## WEST VIRGINIA HISTORIC PROPERTY INVENTORY FORM

| <b>Street Address</b><br>N side Old Martinsburg<br>Grade Road, NE of<br>Bear Wallow Road | <b>Common/Historic<br/>Property Name/<br/>Both</b> | <b>Field Survey #</b><br>Central Hampshire County<br>Survey No. 222 | <b>Site # (SHPO Only)</b><br><br>HM-1023 |

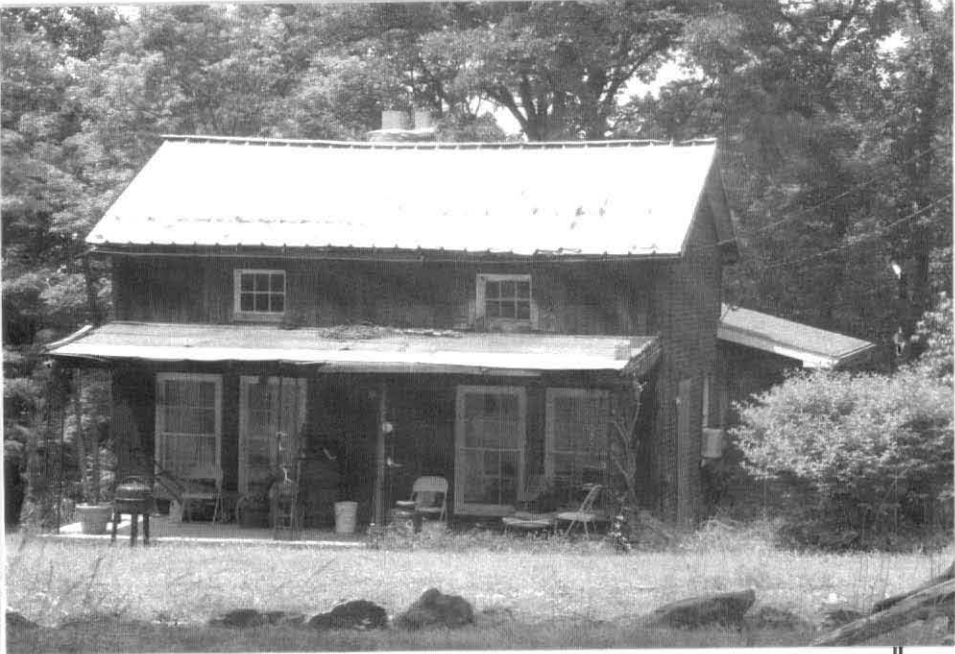
| 2-story vernacular residence of wood construction, with some board-and-batten finishes and some Insul-brick finishes. The building exhibits a 5-bay first story with a centered entrance flanked by 6/6 windows; the second floor is penetrated by two 6-light eyebrow windows. Rearward projecting ell and a side porch. | | | | | | | | | |
| <table style="width: 100%; border: none;"> <tr> <td style="width: 15%;"><b>Alterations</b></td> <td style="width: 10%;"> <input checked="" type="checkbox"/> Yes    <input type="checkbox"/> No </td> <td style="width: 75%;"><b>If yes, describe</b></td> </tr> <tr> <td></td> <td></td> <td>Insul-brick finish</td> </tr> </table> | | <b>Alterations</b> | <input checked="" type="checkbox"/> Yes <input type="checkbox"/> No | <b>If yes, describe</b> | | | Insul-brick finish | | |
