## WEST VIRGINIA HISTORIC PROPERTY INVENTORY FORM

| <b>Street Address</b><br>S side Old Martinsburg<br>Grade Road, W of SR<br>29 | <b>Common/Historic<br/>Property Name/<br/>Both</b> | <b>Field Survey #</b><br>Central Hampshire County<br>Survey No. 226 | <b>Site # (SHPO Only)</b><br><br><i>HM-1027</i> |

Central Hampshire County Historic Resource Survey, 2009

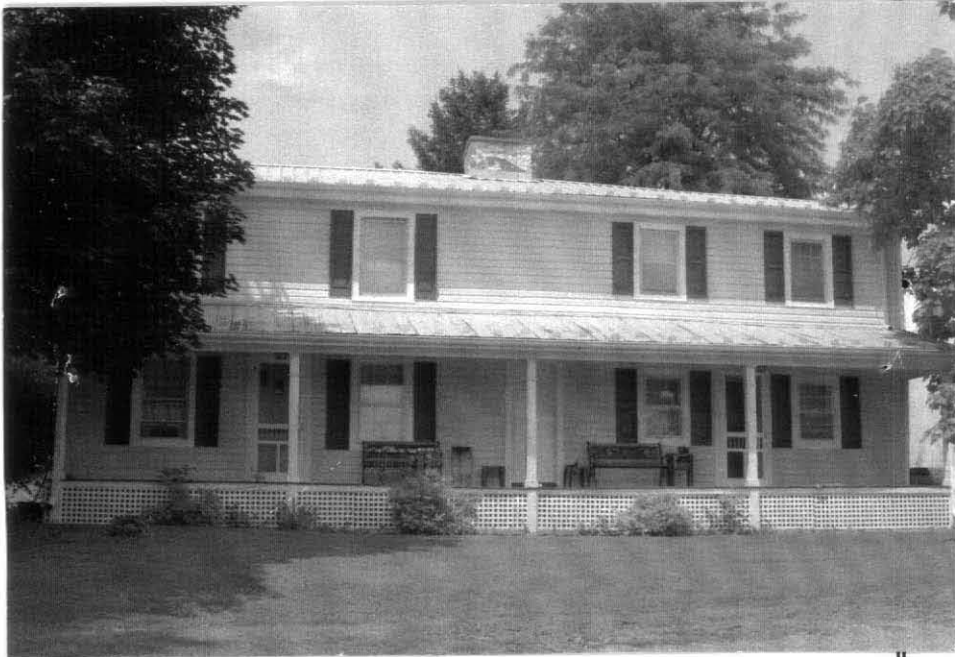
| 2-story vernacular residence of wood construction, with a 7-bay first story and 4-bay second story. Building is originally of log, and is presently finished in non-historic siding. Building has a side-gabled roof with a centered chimney of stone. It was built in several sections, beginning with a 2-story log section which dates from ca. 1850, with additions dating from the 1890's. Extending across the entire façade is a shed-roofed porch finished in standing-seem metal, and supported by historic wood posts. Fenestration is flat-topped, with 6/6 sash, to which have been added non-historic fixed exterior shutters. | |
| <b>Alterations</b> <input checked="" type="checkbox"/> <b>Yes</b> <input type="checkbox"/> <b>No</b> | <b>If yes, describe</b><br>Non-historic siding installed at indeterminate time |
