## WEST VIRGINIA HISTORIC PROPERTY INVENTORY FORM

| <b>Street Address</b><br><br>N side Three Churches Hollow Road, c. 1 mi. W of Jersey Mountain Road | <b>Common/Historic Property Name/ Both</b> | <b>Field Survey #</b><br><br>Central Hampshire County<br>Survey No. 237 | <b>Site # (SHPO Only)</b><br><br><i>HM-1039</i> |

Central Hampshire County Historic Resource Survey, 2009

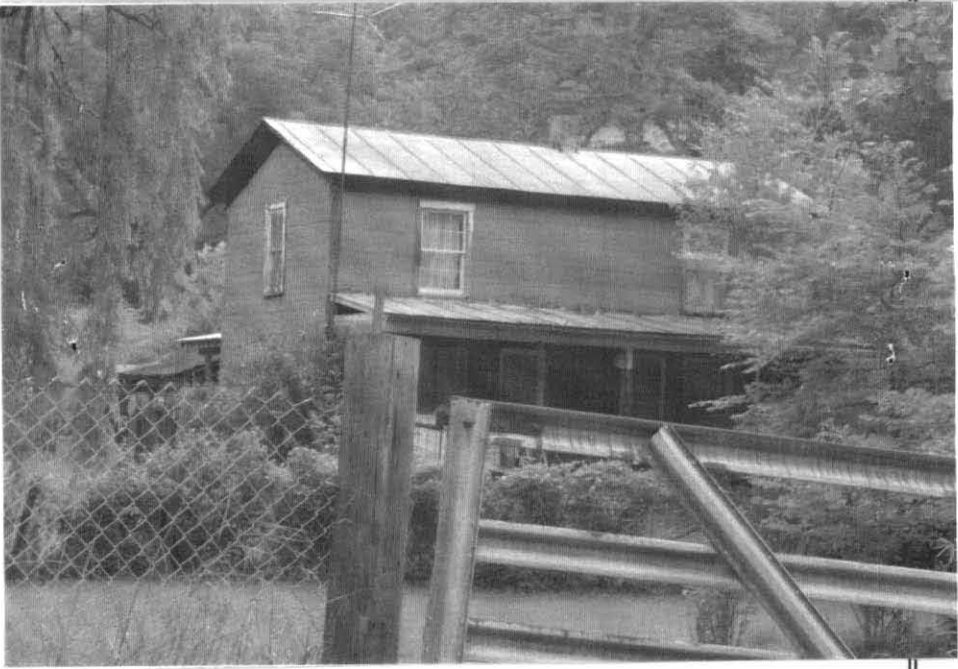
| 2-story vernacular residence of wood construction, finished in insul-brick, with some 6/6 windows retained. Extending across the façade is a shed-roofed porch with a standing-seem metal roof, supported by plain wood posts. A rearward-projecting ell is visible, but "no trespassing" signage precludes closer investigation. <div style="text-align: right; margin-top: 10px;">(Use Continuation Sheets)</div> | | | | | | | | | |
| <table style="width: 100%; border: none;"> <tr> <td style="width: 15%;"><b>Alterations</b></td> <td style="width: 10%;"> <input checked="" type="checkbox"/> <b>Yes</b>      <input type="checkbox"/> <b>No</b> </td> <td style="width: 75%;"> <b>If yes, describe</b><br/> Insul-brick siding installed </td> </tr> </table> | | <b>Alterations</b> | <input checked="" type="checkbox"/> <b>Yes</b> <input type="checkbox"/> <b>No</b> | <b>If yes, describe</b><br>Insul-brick siding installed | | | | | |
| <b>Alterations</b> | <input checked="" type="checkbox"/> <b>Yes</b> <input type="checkbox"/> <b>No</b> | <b>If yes, describe</b><br>Insul-brick siding installed | | | | | | | |

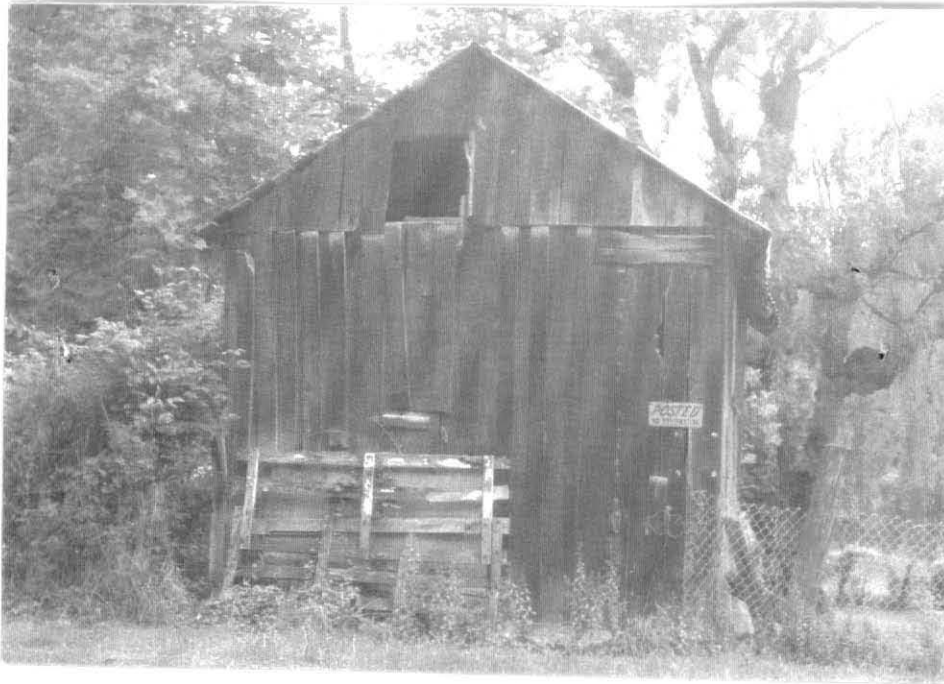
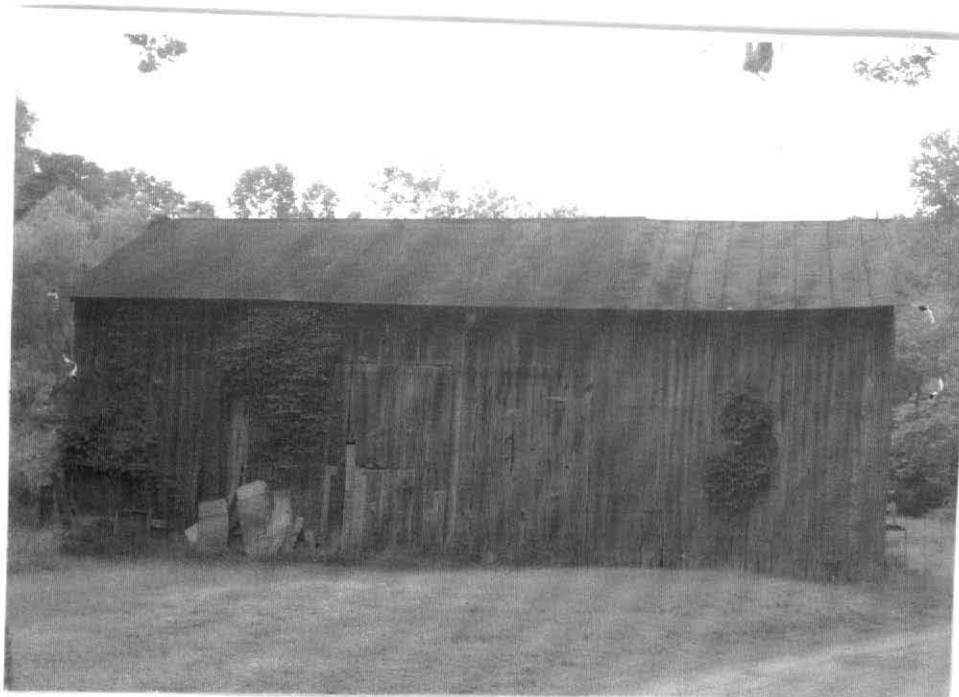
237

| Associated with the property is a moderately sized ground barn of wood construction with a side-gable roof of standing-seem metal and hinged garage doors; the barn is finished in vertical wood siding. <div style="text-align: right; margin-top: 10px;">(Use Continuation Sheets)</div> | | | | | | | | | |
