## WEST VIRGINIA HISTORIC PROPERTY INVENTORY FORM

| <b>Street Address</b><br><br>Unnamed lane N of<br>Frenches Station Road,<br>N of Levels | <b>Common/Historic<br/>Property Name/<br/>Both</b> | <b>Field Survey #</b><br><br>Central Hampshire County<br>Survey No. 276 | <b>Site # (SHPO Only)</b><br><br><i>HM-1079</i> |
| <b>Town or Community</b><br><br>vic. Levels | <b>County</b><br><br>Hampshire | <b>Image No.</b><br><br>3784 | <b>NR Listed Date</b><br><br>n/a |

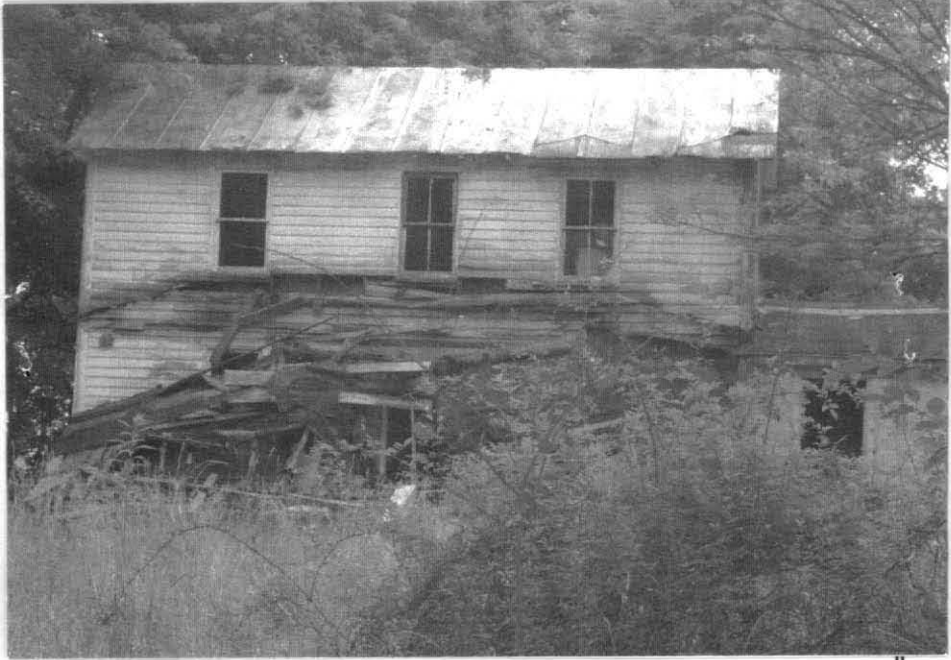
| Deteriorated 3-bay residence of wood construction with a side-gable roof and 1/1 and 2/2 windows. The front porch has collapsed and an addition on the right side appears in danger of collapse. The building is vacant and badly deteriorated. | | | | | | | | | |
| <table style="width: 100%; border: none;"> <tr> <td style="width: 15%;"><b>Alterations</b></td> <td style="width: 10%;"> <input checked="" type="checkbox"/> Yes    <input type="checkbox"/> No </td> <td style="width: 75%;"><b>If yes, describe</b></td> </tr> <tr> <td></td> <td></td> <td>Deterioration</td> </tr> </table> | | <b>Alterations</b> | <input checked="" type="checkbox"/> Yes <input type="checkbox"/> No | <b>If yes, describe</b> | | | Deterioration | | |
| <b>Alterations</b> | <input checked="" type="checkbox"/> Yes <input type="checkbox"/> No | <b>If yes, describe</b> | | | | | | | |
| | | Deterioration | | | | | | | |
