## WEST VIRGINIA HISTORIC PROPERTY INVENTORY FORM

| <b>Street Address</b><br><br>Springfield Grade Road<br>at Arnold Stickley Road | <b>Common/Historic<br/>Property Name/<br/>Both</b> | <b>Field Survey #</b><br><br>Central Hampshire County<br>Survey No. 298 | <b>Site # (SHPO Only)</b><br><br><i>Hm-1103</i> |

Central Hampshire County Historic Resource Survey, 2009

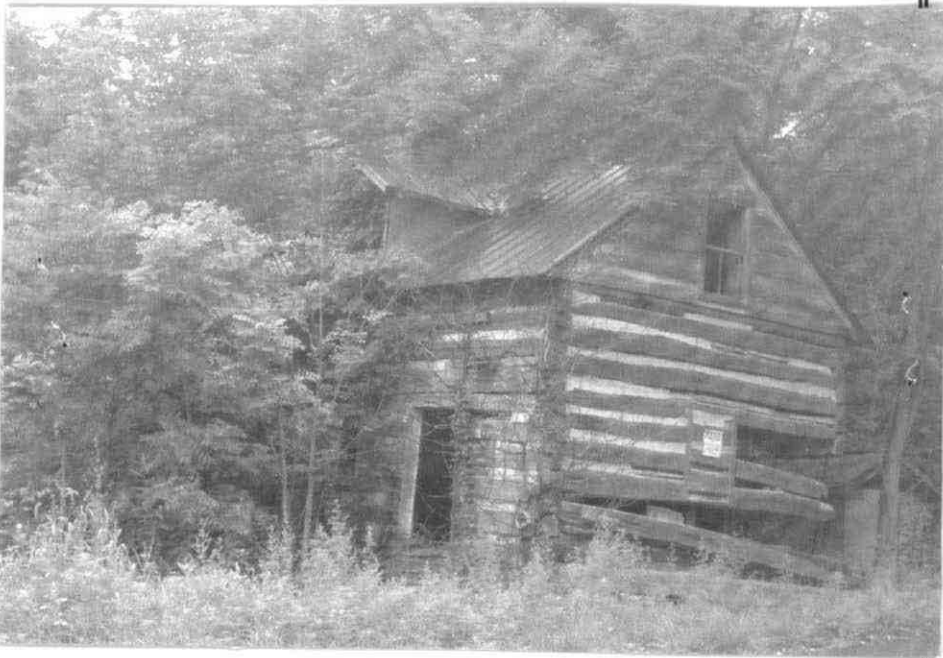
| 2-story log house, vacant and deteriorating, with a side-gable roof and exterior gable-end stone chimney. The slope of the roof on the façade is penetrated by a gable dormer. Steeple corner-notching. | | | | | | | | | |
