## WEST VIRGINIA HISTORIC PROPERTY INVENTORY FORM

| <b>Street Address</b><br>E side Springfield-<br>Green Spring Road | <b>Common/Historic<br/>Property Name/<br/>Both</b> | <b>Field Survey #</b><br>Central Hampshire County<br>Survey No. 347 | <b>Site # (SHPO Only)</b><br><br><i>HM-1153</i> |

Central Hampshire County Historic Resource Survey, 2009

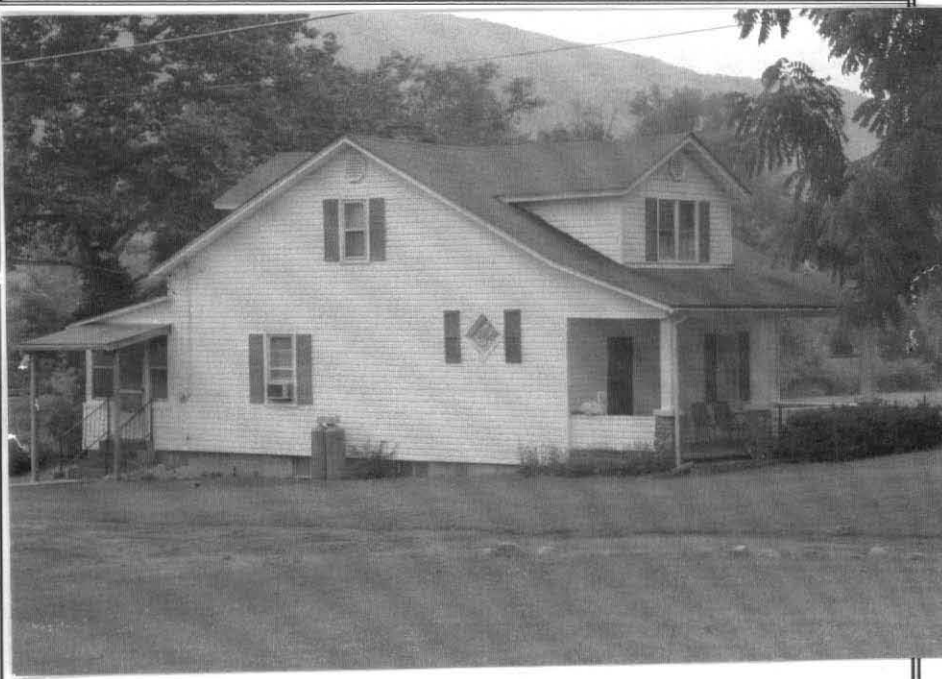
| <p>1½-story Craftsman-style Bungalow of wood construction, with a side gable roof and gable dormers front and rear. The roof extends beyond the plain of the building to shield a recessed front porch which is supported by wood piers which rest on bases of cobblestone; the porch is enclosed within a solid wood balustrade. Fenestration is generally flat-topped, with replacement sash and exterior fixed shutters. A diamond-paned single light window is on the side elevation, likely opening into a stairwell inside. The original back porch has been enclosed.</p> | | | | |
| <table style="width: 100%;"> <tr> <td style="width: 15%;"><b>Alterations</b></td> <td style="width: 10%;"> <input checked="" type="checkbox"/> Yes    <input type="checkbox"/> No </td> <td style="width: 75%;"> <b>If yes, describe</b><br/> Non-historic siding installed at indeterminate time </td> </tr> </table> | | <b>Alterations</b> | <input checked="" type="checkbox"/> Yes <input type="checkbox"/> No | <b>If yes, describe</b><br>Non-historic siding installed at indeterminate time |
| <b>Alterations</b> | <input checked="" type="checkbox"/> Yes <input type="checkbox"/> No | <b>If yes, describe</b><br>Non-historic siding installed at indeterminate time | | |
| <p>Associated with the property is a 1-story gable-end-oriented garage of wood construction.</p> | | | | |
| <p>This house is architecturally undistinguished, has been altered, and does not appear to meet National Register Criteria for Evaluation.</p> | | | | |
