## WEST VIRGINIA HISTORIC PROPERTY INVENTORY FORM

| <b>Street Address</b><br>U.S. 220 | <b>Common/Historic Name/Both</b><br><div style="display: flex; justify-content: space-around;"> <input type="radio"/> <input type="radio"/> <input type="radio"/> </div> | <b>Field Survey #</b><br>HM-1183 | <b>Site # (SHPO Only)</b><br>see also HM-0091-0007 |
| <b>Town or Community</b><br>Purgitsville vicinity | <b>County</b><br>Hampshire | <b>Negative No.</b><br>WV_HampshireCounty_HM-1183.tif | <b>NR Listed Date</b> |

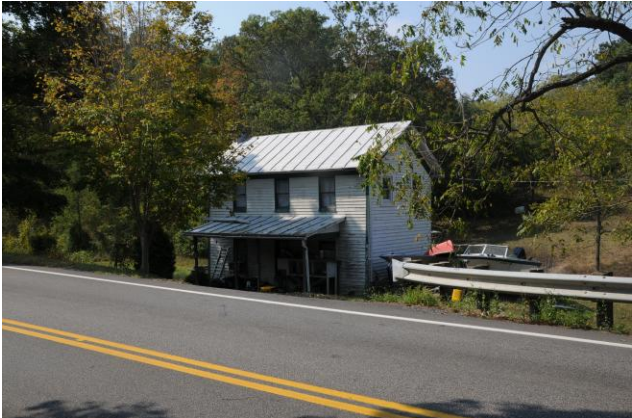
| <b>Description of Building or Site (Original and Present)</b> <div style="text-align: right; float: right;"> 2 Stories    3 Front Bays </div> <p>Center hall I-house with massive stone chimney on the left gable end. Two/2 double hung sash that are probably original. Deep window reveals and lapped siding with corner boards that probably covers log construction. Shed roof front porch with plain wood supports.</p> | |
| <b>Describe All Outbuildings</b><br>Small barn of wood with metal roof<br><br><div style="text-align: right;"><i>(Use Continuation Sheets)</i></div> | |
