## WEST VIRGINIA HISTORIC PROPERTY INVENTORY FORM

| <b>Street Address</b><br>Rt. 220/28 | <b>Common/Historic Name/Both</b><br>X            O            O<br>Marvin Chapel UM Church | <b>Field Survey #</b><br>HM-1191 | <b>Site # (SHPO Only)</b><br>see also HM-0090-0001 |
| <b>Town or Community</b><br>Purgitsville vicinity | <b>County</b><br>Hampshire | <b>Negative No.</b><br>WV_Hampshire<br>County_HM-1191.tif | <b>NR Listed Date</b> |

Name: Marvin Chapel

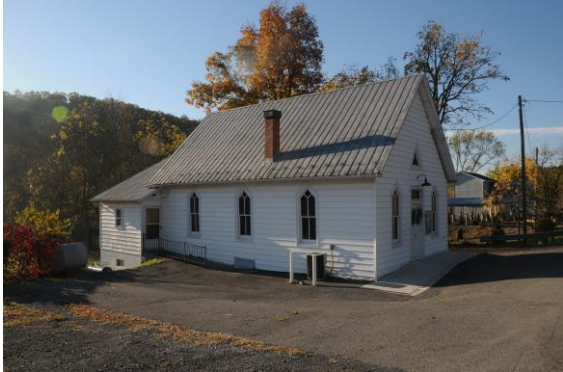
| <b>Description of Building or Site (Original and Present)</b> <div style="text-align: right;">1    Stories    ____ 3 ____ Front Bays</div> Center hall, double doors with transom over, flanked by 1/1 double hung Gothic windows. Gable front with Gothic triangular window over entry system. Wide eave overhang, steep roof pitch. Right rear shed roofed winglet with entrance, one story rear extension<br><br><i>(Use Continuation Sheets)</i> | | | | | | | | | |
| <table style="width: 100%; border: none;"> <tr> <td style="width: 15%;"><b>Alterations</b></td> <td style="width: 10%; text-align: center;"> <input checked="checked" type="checkbox"/> </td> <td style="width: 10%; text-align: center;"> <input type="checkbox"/> </td> <td style="width: 65%;">If yes, describe    Aluminum siding</td> </tr> <tr> <td></td> <td style="text-align: center;">Yes</td> <td style="text-align: center;">No</td> <td></td> </tr> </table> | | <b>Alterations</b> | <input checked="checked" type="checkbox"/> | <input type="checkbox"/> | If yes, describe    Aluminum siding | | Yes | No | |
| <table style="width: 100%; border: none;"> <tr> <td style="width: 15%;"><b>Additions</b></td> <td style="width: 10%; text-align: center;"> <input checked="checked" type="checkbox"/> </td> <td style="width: 10%; text-align: center;"> <input type="checkbox"/> </td> <td style="width: 65%;">Rear Extension</td> </tr> <tr> <td></td> <td style="text-align: center;">Yes</td> <td style="text-align: center;">No</td> <td></td> </tr> </table> | | <b>Additions</b> | <input checked="checked" type="checkbox"/> | <input type="checkbox"/> | Rear Extension | | Yes | No | |

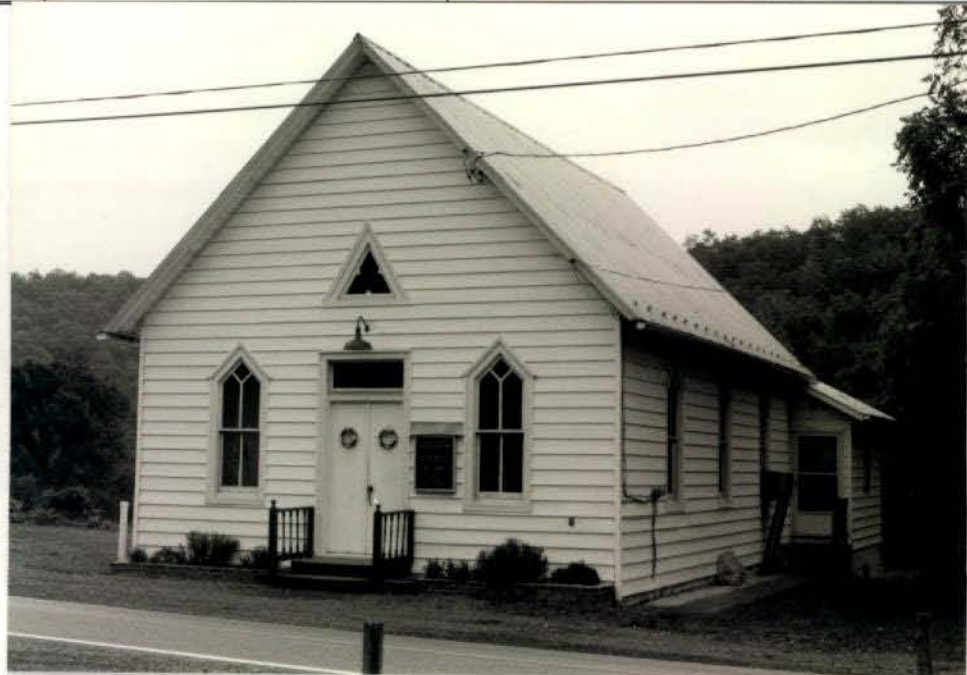
| <b>Description of Buildings or Site (Original and Present)</b> <div style="text-align: right;">1 Stories      2 Front Bays</div> <p>The Marvin Chapel has a gabled roof with snowshoes. Double hung, double sashed, multi-paned, lancet Arch windows; two in front three on each side. Double doors with a transom window, and a triangular shaped mid-gabled window above the door..</p> | |
| <b>Alterations</b> <input checked="" type="checkbox"/> Yes <input type="checkbox"/> No    If yes, describe<br>Addition of Vinyl siding. | |
