## HISTORIC PROPERTIES INVENTORY FORM

| 1 | NAME | COMMON | Frame House with Stone End Chimney |

CORRIDOR "H" FIELD REVIEW PROJECT

Property name: Frame House with Stone End Chimney (043-H-Hm-16)

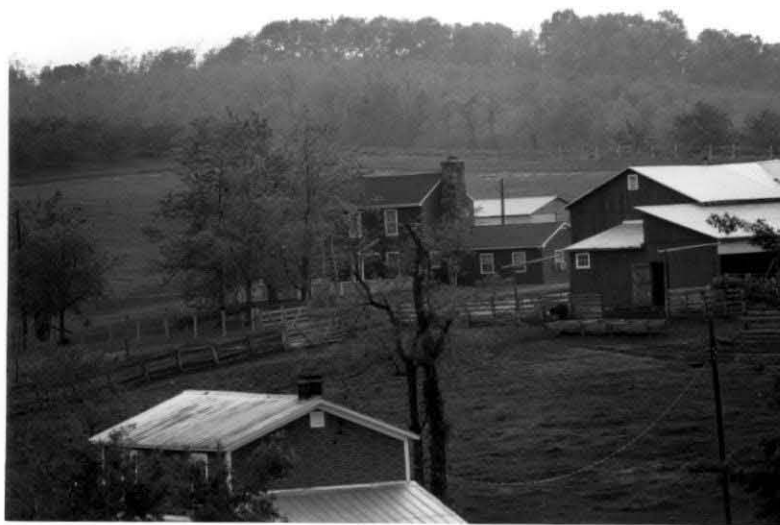
NAME Frame House with Stone  
End Chimney

| | | PHYSICAL DESCRIPTION (include photograph if possible) | The main section of this central house of a farm complex is a frame, two-story unit with gable roof. A substantial stone exterior end chimney is at one side. Windows in the three-bay front are 6/6. A more recent extension (one story) has been added on the chimney side. |

Possible mitigation of effect: 1. Shift alignment or redesign with such features as a narrower median, if feasible. 2. Move the structure if integrity will not be overly diminished. 3. Record with measured drawings (to standards of the Historic American Buildings Survey), photographs and written historical information. 4. Make architectural building elements available for display or reuse.
