## WEST VIRGINIA HISTORIC PROPERTY INVENTORY FORM

| <b>Street Address CR 8</b><br><br>River Road | <b>Common/Historic Name/Both</b><br>x            O            O<br>Parker-Scanlon house | <b>Field Survey #</b><br>HM-1308 | <b>Site # (SHPO Only)</b><br><br>HM-0077 |

Parker-Scanlon Home

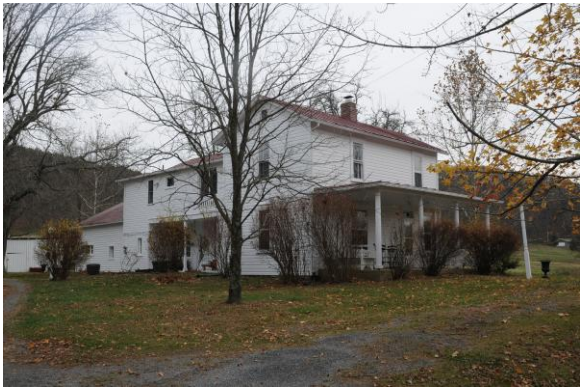
| <b>Description of Building or Site (Original and Present)</b> 2 Stories    3 Front Bays<br>Center hall, 1/1 double hung sash wide window trim, interior brick chimney, low hipped porch roof with four Doric columns and no railing. Two story rear extension and one story rear extension that is likely to be log construction. | |

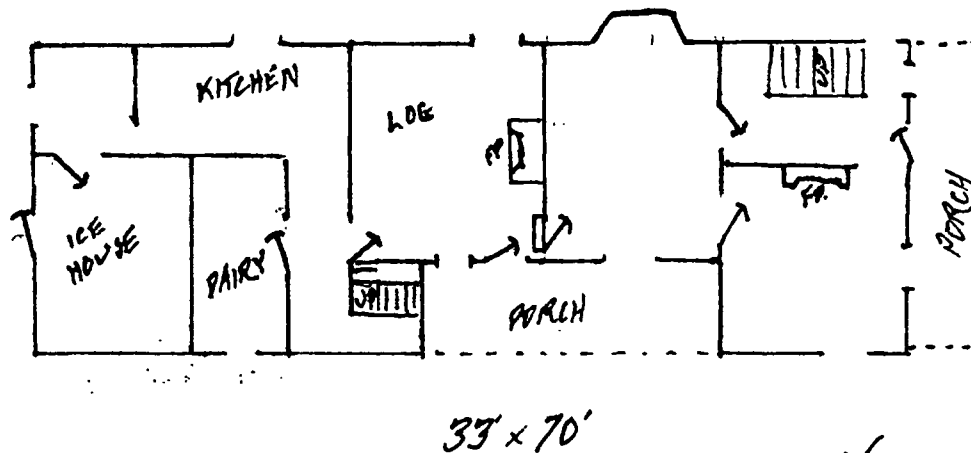
7. PLAN (include approx. dimensions):

33' x 70'
