## WEST VIRGINIA HISTORIC PROPERTY INVENTORY FORM

| <b>Street Address</b><br>Northeast corner of Main and Bolton Street | <b>Common/Historic Name/Both</b><br><div style="text-align: center;"> <input type="radio"/>      <input type="radio"/>      <input type="radio"/> </div> Davis House | <b>Field Survey #</b><br>24 | <b>Site # (SHPO Only)</b><br>HM-0155 |

## 24. Davis House (traditionally dated to before 1798)

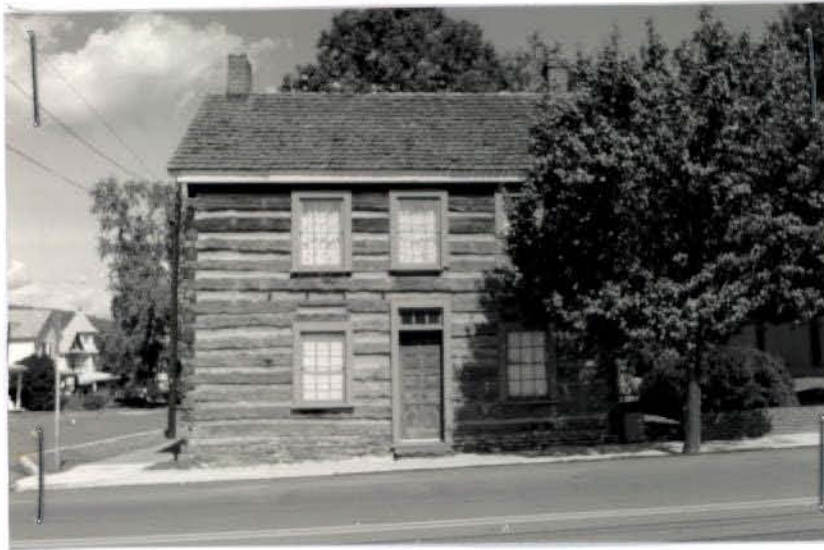
Negative #10

This charming, but very heavily restored, 2-story, 3-bay log cabin is 14 log rounds high and joined at the corners with V-notches. Adze marks remain visible on the logs. Walls rest on a fieldstone foundation. The gable roof is covered with shake shingles and pierced on either side by an interior brick chimney. The cornice is boxed. The backs of the fireplaces are exposed in the gable ends on both the 1<sup>st</sup> and 2<sup>nd</sup> story. The 8-panel door is topped by a 3-light transom. The 6/6 sash windows are reproductions. A 2-story, German-sided, frame ell extends from the back of the building. According to tradition this log house was built before 1798 and is considered to be the oldest building in Romney. This attribution is probably based on lot information provided in the 1798 Federal Direct Tax. The very excellent condition of the logs, however, makes this early construction date somewhat suspect. More research, and possibly dendrochronology, is necessary to determine the building's date of construction. An old blacksmith shop is also associated with the house.
