## WEST VIRGINIA HISTORIC PROPERTY INVENTORY FORM

| <b>Street Address</b><br>25 and 29 Main Street | <b>Common/Historic Name/Both</b><br><div style="text-align: center;"> <input type="radio"/>   <input type="radio"/>   <input type="radio"/> </div> Ralph W. Haines Law Office<br>(Common) | <b>Field Survey #</b><br>30 | <b>Site # (SHPO Only)</b><br>HM-0187 |

NAME Romney Commercial Historic District

## 30. 25 and 29 Main Street (c. 1900)

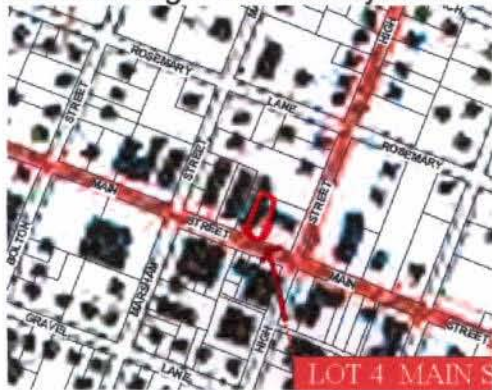
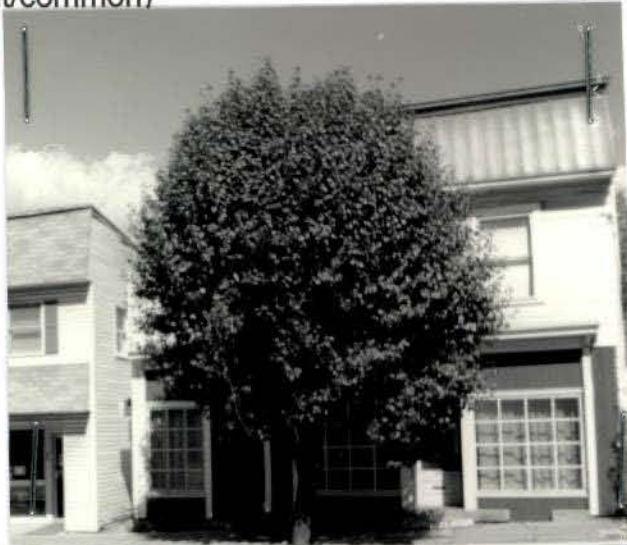
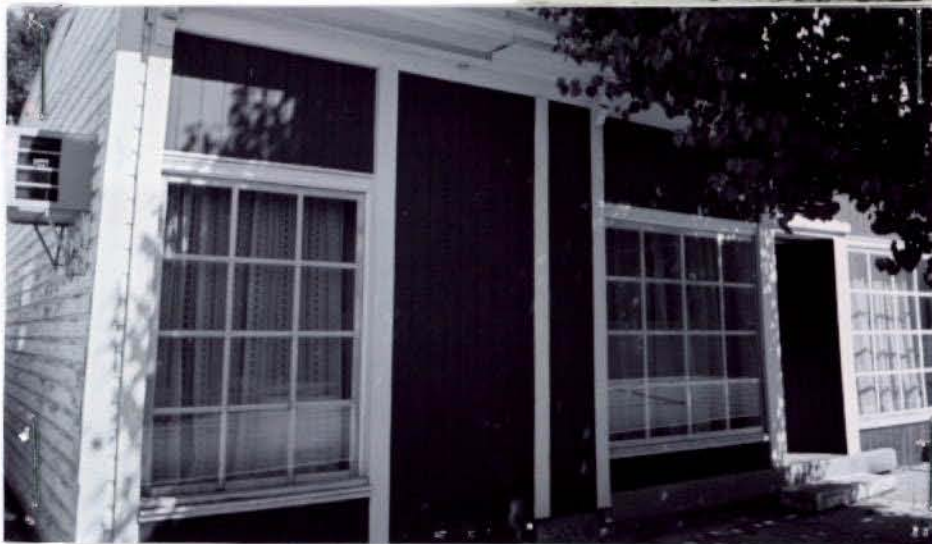
Negative #5

This 2-story, frame, commercial building shares many similarities with its slightly smaller neighbor at 43 West Main Street. Unfortunately these similarities extend to include extensive and unsympathetic alterations. Walls are sheathed with aluminum siding and the 1<sup>st</sup>, 2<sup>nd</sup>-story windows are modern replacements. The commercial storefront features a modern, asymmetric reconfiguration. Its windows are large, multi-light, fixed types. The standing-seam, shed roof extends over the front façade in a manner similar to the neighboring building. Despite these unfortunate changes, this building retains sufficient integrity to warrant designation as a contributing resource.
