## WEST VIRGINIA HISTORIC PROPERTY INVENTORY FORM

| <b>Street Address</b><br>Southeast corner of North High Street<br>and East Rosemary Lane | <b>Common/Historic Name/Both</b><br>O O O<br>Romney Jail | <b>Field Survey #</b><br>41 | <b>Site # (SHPO Only)</b><br>HM-0533 |

NAME Romney Commercial Historic District

**41. Romney Jail (pre-Civil War; popularly dated to 18<sup>th</sup> century)**

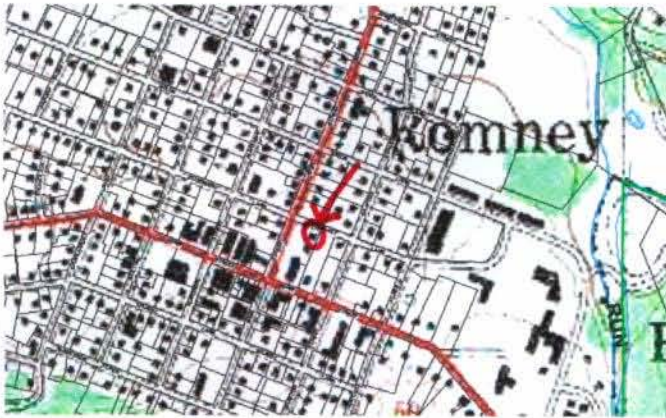
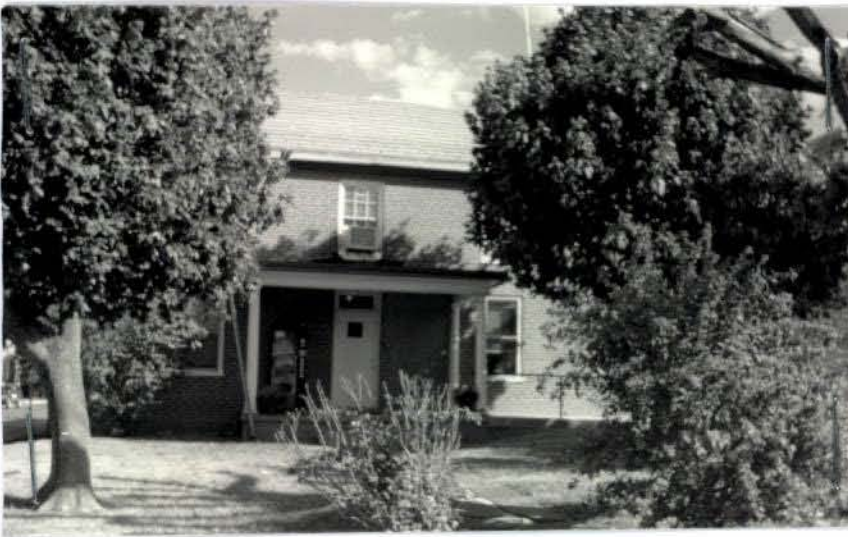
Negative # 2A and 3A

The former Romney Jail consists of a two sections. The front portion is a 2-story, 3-bay, gable-roofed former dwelling. Its brick walls are mostly laid up in 5:1 common bond brick. An exception is six courses of ashlar stone forming most of the 1<sup>st</sup> story of the north gable end. This feature appears to be original as the

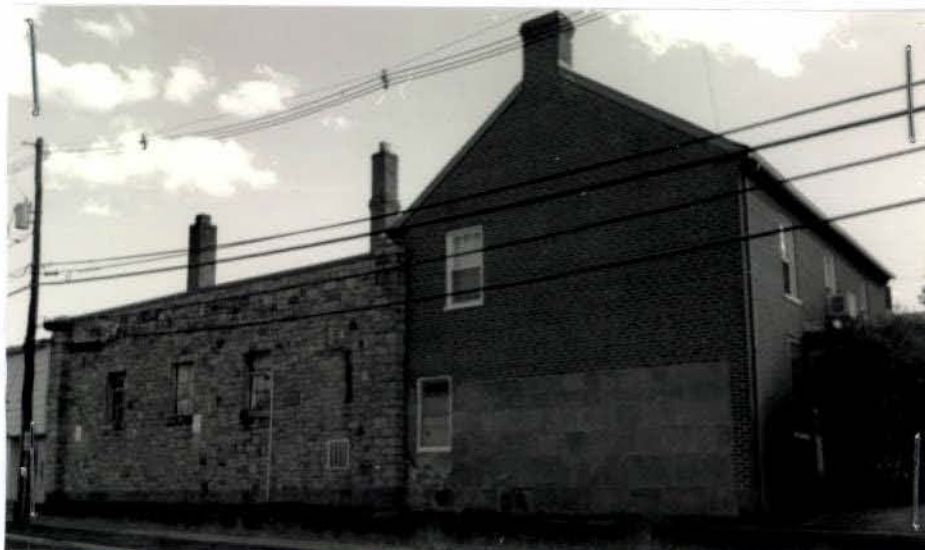
foundation utilizes the same type of stone. The gable roof displays very little overhang with corbelled bricks accenting the façade's cornice. The centrally placed entrance is fitted with a modern metal security door, but the opening retains an original 3-light transom window. A relatively modern, hipped-roof portico protects the entrance. Windows consist of a mix of 6/6 and replacement 1/1 types. First-story, north-wall windows are absent glazing, but retain sash. This section housed the jail keeper and his family. It is currently used for office space.

The 1-story, flat-roofed, stone jail block extends from the rear (east) of the brick section. Walls are constructed of irregularly coursed ashlar stone. Three, 3/6 metal-sash windows illuminate the building's north wall. A tall, but not identical, chimney stack pierces the roof at the east and west ends. A *View of Romney*, printed in the *New York Illustrated News* on February 1, 1862 shows the jail's brick section. The illustration's perspective does not provide a view of the stone portion, but the similarities in the foundation of the two sections suggest the two parts are contemporaneous. The Old Romney Jail is in good condition and contributes to the Romney Historic Commercial District.
