## WEST VIRGINIA HISTORIC PROPERTY INVENTORY FORM

| <b>Street Address</b><br>36 North Marsham Street | <b>Common/Historic Name/Both</b><br><div style="text-align: center;"> <input type="radio"/>   <input type="radio"/>   <input type="radio"/> </div> Wappocomo Post #1101 of Foreign Wars | <b>Field Survey #</b><br>45 | <b>Site # (SHPO Only)</b><br>HM-0023 |

NAME Romney Commercial Historic District

## 45. Wappocomo Post #1101 Veterans of Foreign Wars

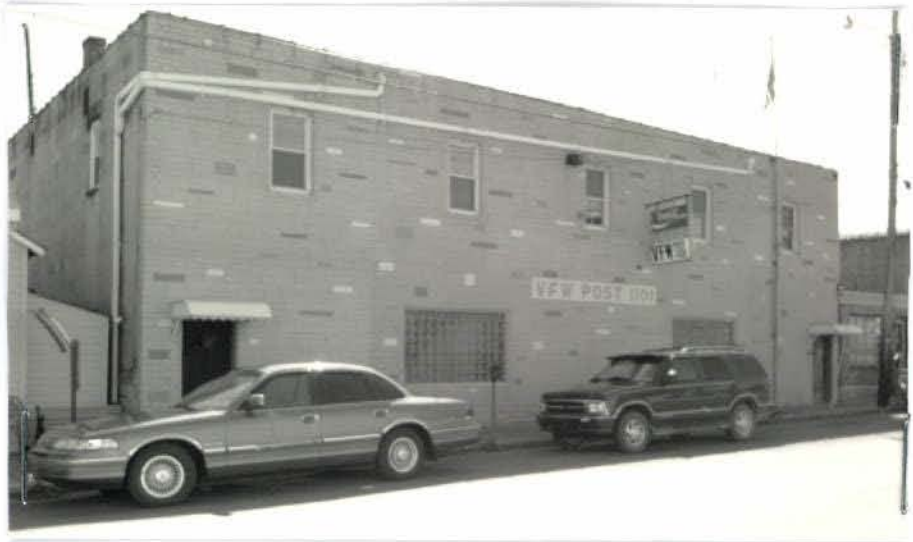
Negative #12

Measuring approximately 120' x 80', the Wappocomo Post #1101 Veterans of Foreign Wars building dominates this side of the block. It is a 2-story, flat-roof, concrete-block structure. In an attempt at decoration, the front façade of this otherwise plain, utilitarian structure was clad in polychrome formstone. For unknown reasons the internal guttering system exits the building on the front wall and declines along the façade before engaging a downspout on the north side wall. Front wall fenestration consists of five, equally spaced, 1/1 windows on the second level. The first story contains two large bays of glass-block windows. Entrances are located at either end of the front façade. These grade-level openings are covered by an aluminum awning and fitted with a wooden, interior-grade door. Most side and rear wall windows are enclosed with concrete blocks, but the original brick flat-arches and sills remain in place. The VFW building does not contribute to the Romney Commercial Historic District due to a near total loss of integrity.
