## WEST VIRGINIA HISTORIC PROPERTY INVENTORY FORM

| <b>Street Address</b><br>U.S. Rt. 50 | <b>Common/Historic Name/Both</b><br><div style="text-align: center;"> <input type="radio"/>   <input type="radio"/>   <input type="radio"/> </div> United Methodist Church | <b>Field Survey # HM-0279</b> | <b>Site # (SHPO Only)</b><br><div style="text-align: center; font-size: 1.2em;">HM-0324</div> |
| <b>Town or Community</b><br>Loom | <b>County</b><br>Hampshire | <b>Negative No.</b><br>WV_Hampshire<br>County_HM-0279 | <b>NR Listed Date</b> |

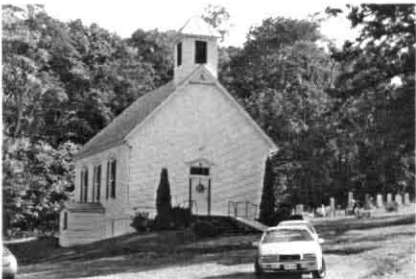
| Center entry with transom and pedimented portico. Square belfry with vents and hipped roof, side faces each have 2/2 double hung sash with decorative shutters and pedimented arches with an oculus motif. Cemetery with 94 burials. | |
| Alterations <div style="display: inline-block; vertical-align: middle; margin-left: 10px;"> <input checked="checked" type="checkbox"/> Yes<br/> <input type="checkbox"/> No </div> | If yes, describe Vinyl siding |
