# WEST VIRGINIA HISTORIC PROPERTY INVENTORY FORM

| <b>Street Address</b><br>North Texas Road | <b>Common/Historic Name/Both</b><br><input type="radio"/> <input type="radio"/> <input type="radio"/> | <b>Field Survey #</b><br>HM-0718 | <b>Site # (SHPO Only)</b><br>HM-0766 |
| <b>Town or Community</b><br>Augusta vicinity | <b>County</b><br>Hampshire | <b>Negative No.</b><br>WV_Hampshire County_HM-0718.tif | <b>NR Listed Date</b> |

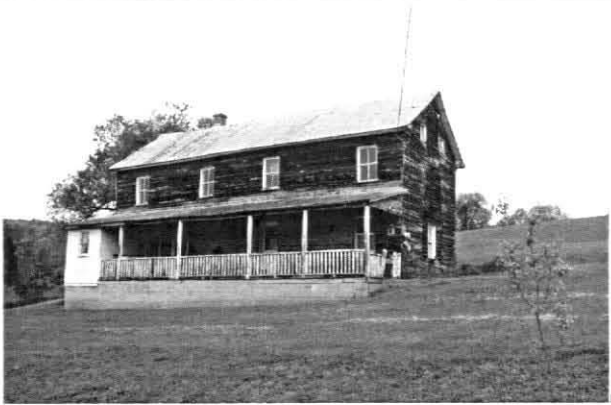
| Double log house built in two sections with 2/2 double hung sash, steep pitched roof, rebuilt front porch, which has small portion enclosed. Owner explained that the gable end chimney was removed about 100 years ago for foundation stones for another building. Center brick chimney | |
| Alterations<br><input checked="checked" type="checkbox"/> Yes <input type="checkbox"/> No | If yes, describe rebuilt porch and removed chimney, small enclosure on porch. |
