## WEST VIRGINIA HISTORIC PROPERTY INVENTORY FORM

| <b>Street Address</b><br>Rt. 50 | <b>Common/Historic Name/Both</b><br><div style="display: flex; justify-content: space-around;"> <input type="radio"/>    <input type="radio"/>    <input type="radio"/> </div> | <b>Field Survey #</b><br>HM-0726 | <b>Site # (SHPO Only)</b><br>HM-0774 |
| <b>Town or Community</b><br>Augusta | <b>County</b><br>Hampshire | <b>Negative No.</b><br>WV_Hampshire<br>County_HM-0726.tif | <b>NR Listed Date</b> |

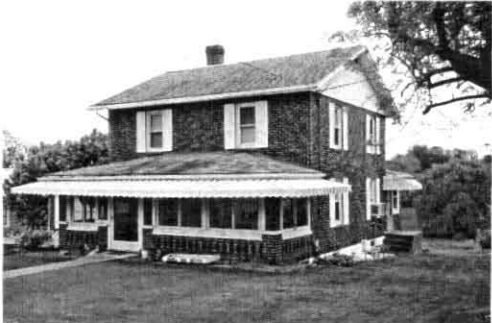
Photograph

| Description of Building or Site (Original and Present) <span style="float: right;">__2__ Stories   3__ Front Bays</span><br>Center hall with 1/1 double hung sash and decorative shutters. Brick sills and lintels. Hipped roof over front porch supported by brick columns and enclosed by glass sliding windows. Aluminum awnings. Rear one-story front porch is enclosed at the top of a three step brick stairway. Brick railing on the front porch is stylized and decorative. | |
| Alterations <input checked="checked" type="checkbox"/> Yes <input type="checkbox"/> No | If yes, describe Porch enclosure |
| Describe All Outbuildings<br><br>One gambrel roofed wooden barn with rolling door and louvered gable vent NC; One pole shed with Insulbrick siding and metal roof, C. | |
