## WEST VIRGINIA HISTORIC PROPERTY INVENTORY FORM

| Street Address | Common/Historic Name/Both<br>O       O       O | Field Survey #<br>HM-0727 | Site # (SHPO Only)<br><i>HM-0775</i> |
| Town or Community<br>Augusta | County<br>Hampshire | Negative No.<br>WV_Hampshire County_HM-0727.tif | NR Listed Date |

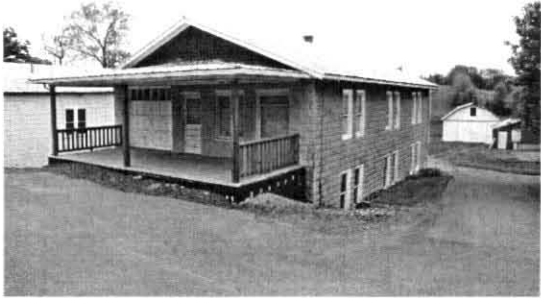
| Building has gable front facade with central entry with paneled door and half-light. Fixed pane windows with glass transoms, and one garage door. Nearly flat porch roof supported by new treated wood square posts, with side railing also of threatened wood. Porch deck is new The building has a daylight basement below a steep grade | |

| Alterations | <input checked="" type="checkbox"/> If yes, describe Porch repairs |
