## WEST VIRGINIA HISTORIC PROPERTY INVENTORY FORM

| <b>Street Address</b><br>Rt. 50 | <b>Common/Historic Name/Both</b><br><div style="text-align: center;"> <input type="radio"/>      <input type="radio"/>      <input type="radio"/> </div> | <b>Field Survey #</b><br>HM-0740 | <b>Site # (SHPO Only)</b><br><div style="font-family: cursive; font-size: 1.2em;">HM-0788</div> |
| <b>Town or Community</b><br>Augusta | <b>County</b><br>Hampshire | <b>Negative No.</b><br>WV_Hampshire<br>County_HM-0740.tif | <b>NR Listed Date</b> |
| <b>Architect/Builder</b> | <b>Date of Construction</b><br>Circa 1930 | <b>Style</b><br>Craftsman bungalow | |

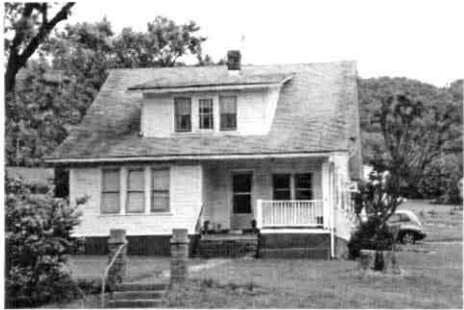
Photograph

| Description of Building or Site (Original and Present)      _ 1 1/2 _ Stories      _ 3 _ Front Bays<br>Sweeping roof shelters 1/2 width porch. Center hall in recessed porch 1/1 double hung sash, corner roof support is square pillar with plain spindle railing. Wide eave overhand with stylized exposed brackets. Three light shed roofed center front dormer, interior brick chimney. Large rear extension. Brick pillars flank the end of the concrete sidewalk. | |
| House retains a high degree of its integrity | |
