## WEST VIRGINIA HISTORIC PROPERTY INVENTORY FORM

| <b>Street Address</b><br>E side Heidiecooper Rd., c. .5 mi. S of U. S. Rt. 50 | <b>Common/Historic Property Name/ Both</b> | <b>Field Survey #</b><br>Central Hampshire County Survey No. 108 | <b>Site # (SHPO Only)</b><br>Hm-0912 |

Central Hampshire County Historic Resource Survey, 2009

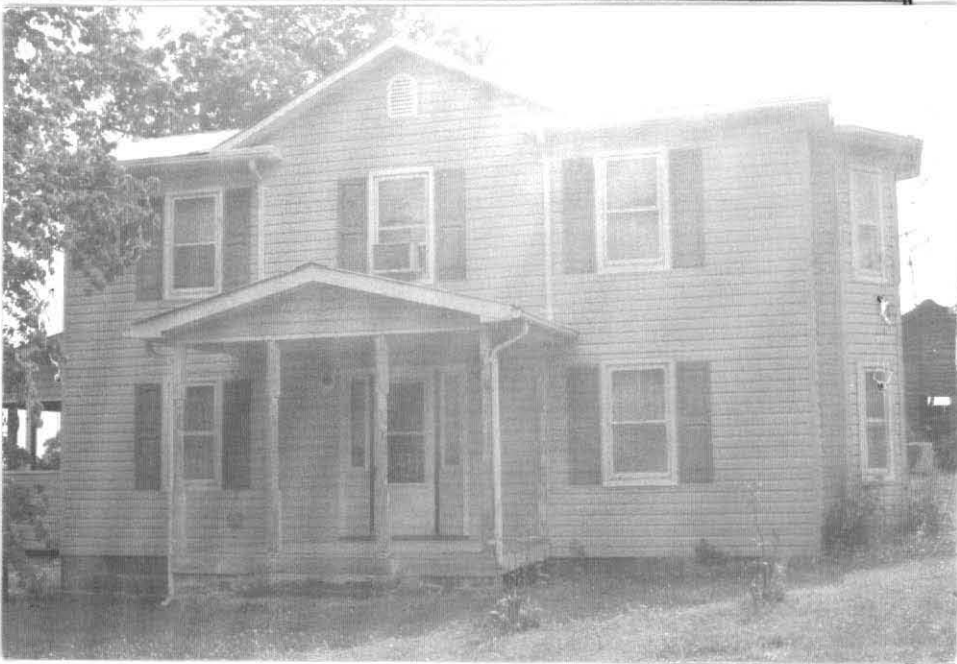
| 2-story vernacular residence of wood construction with an intersecting gable roof penetrated by red brick chimneys. 3-bay façade with a centered entrance flanked by side lights and shielded by a pedimented portico supported by turned posts. Centered pediment on façade, 2-story bay window on the side elevation, and a screened-in shed-roofed porch on piers on the opposite side elevation. Fenestration is flat topped, 2/2, with exterior fixed shutters. | | | | | | | | | |
| <b>Alterations</b> | <input checked="" type="checkbox"/> Yes <input type="checkbox"/> No | <b>If yes, describe</b><br>Non-historic siding and shutters | | | | | | | |
