## WEST VIRGINIA HISTORIC PROPERTY INVENTORY FORM

| <b>Street Address</b><br>N side Old Martinsburg<br>Grade Road, at Jason<br>Haines Road | <b>Common/Historic<br/>Property Name/<br/>Both</b><br>Kidwell House<br>(historic) | <b>Field Survey #</b><br>Central Hampshire County<br>Survey No. 228 | <b>Site # (SHPO Only)</b><br><br><i>Hm-1030</i> |

Central Hampshire County Historic Resource Survey, 2009

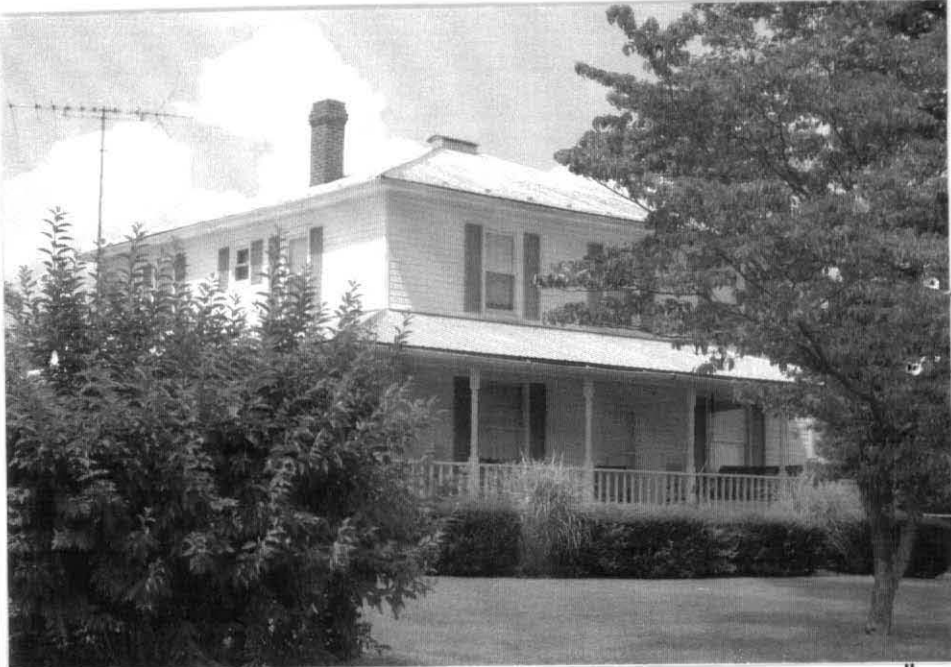
| 2-story hipped-roof vernacular residence of wood construction with a 3-bay façade and wrap-around wood veranda, supported by turned posts and enclosed within a replacement wood balustrade. Fenestration is flat-topped, with replacement sash and exterior fixed shutters. | | | |
| <b>Alterations</b> | <input checked="" type="checkbox"/> <b>Yes</b> | <input type="checkbox"/> <b>No</b> | <b>If yes, describe</b><br>Non-historic siding installed at indeterminate time |

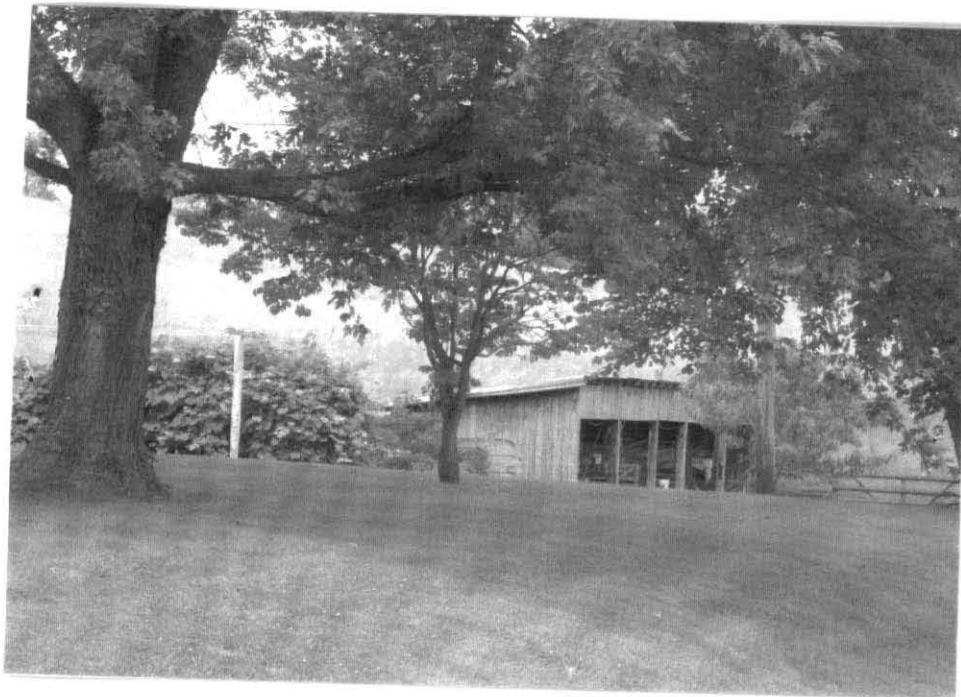
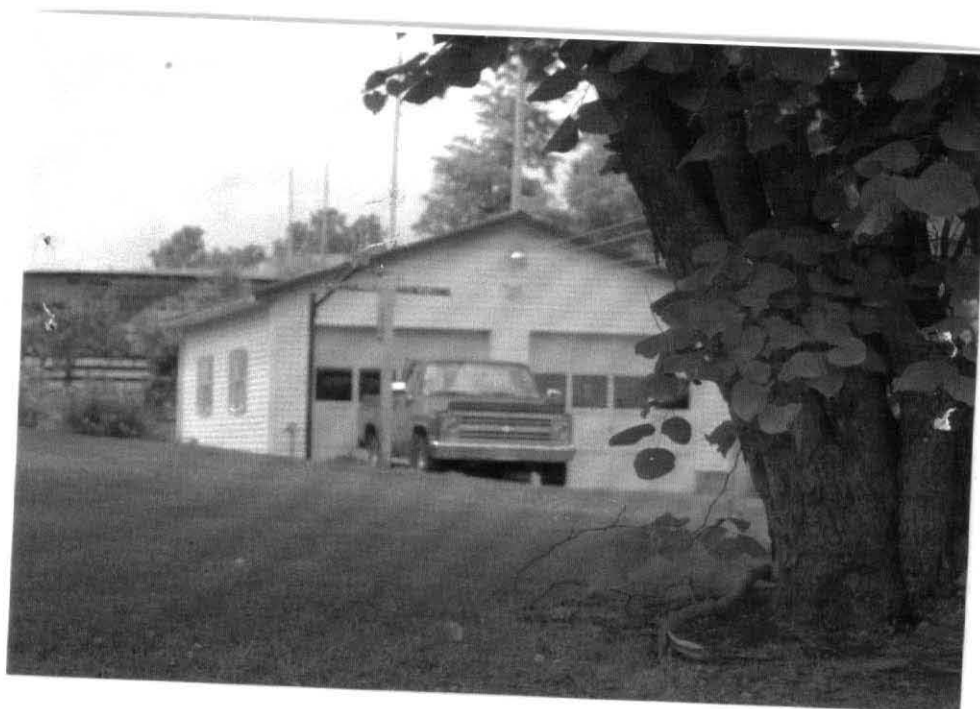
NAME \_\_\_\_\_ Survey Site Number 228

| Behind the house is an open-sided shed with a rearward projecting shed roof and exposed rafter tails. There is also a non-historic 2-bay garage with gable roof and gable-end orientation. | | | (Use Continuation Sheets) |
