## WEST VIRGINIA HISTORIC PROPERTY INVENTORY FORM

| <b>Address</b><br>Rt. 220/28 | <b>Common/Historic Name/Both</b><br><div style="display: flex; justify-content: space-around;"> <span>O</span> <span>O</span> <span>O</span> </div> | <b>Field Survey #</b><br>HM-1192 | <b>Site # (SHPO Only)</b><br>see also HM-0090-0002 |
| <b>Town or Community</b><br>Purgitsville vicinity | <b>County</b><br>Hampshire | <b>Negative No.</b><br>WV_Hampshire<br>County_HM-1192.tif | <b>NR Listed Date</b> |

| <b>Street Address</b><br>US<br>Route 220 | <b>Common/Historic Name/Both</b><br><input checked="" type="checkbox"/> Structure 2 <input type="checkbox"/> <input type="checkbox"/> | <b>Field Survey #</b><br>0002 | <b>Site # (SHPO Only)</b><br>HM-0090-0002 |

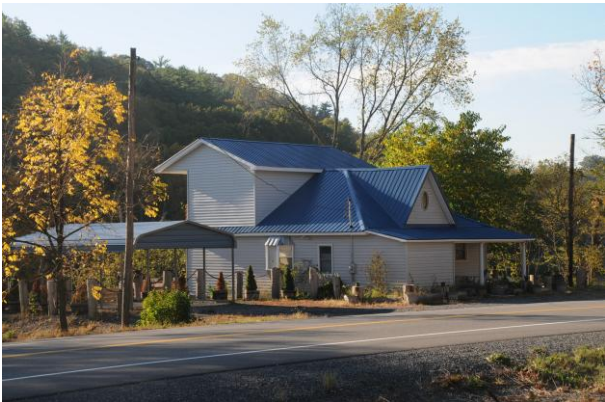
| <b>Description of Building or Site (Original and Present)</b> 2 Stories    ____ 2 ____ Front Bays<br>Large cross-gable house with replacement sliding windows, bay window, raised rear wing.<br><br><i>(Use Continuation Sheets)</i> | | | | |
| <table style="width: 100%;"> <tr> <td style="width: 15%;"><b>Alterations</b></td> <td style="width: 10%;"> <input checked="checked" type="checkbox"/> Yes<br/> <input type="checkbox"/> No </td> <td style="width: 75%;"> <b>If yes, describe</b>    reconfigured footprint, aluminum siding, replacement windows </td> </tr> </table> | | <b>Alterations</b> | <input checked="checked" type="checkbox"/> Yes<br><input type="checkbox"/> No | <b>If yes, describe</b> reconfigured footprint, aluminum siding, replacement windows |
| <b>Alterations</b> | <input checked="checked" type="checkbox"/> Yes<br><input type="checkbox"/> No | <b>If yes, describe</b> reconfigured footprint, aluminum siding, replacement windows | | |
| <table style="width: 100%;"> <tr> <td style="width: 15%;"><b>Additions</b></td> <td style="width: 10%;"> <input checked="checked" type="checkbox"/> Yes<br/> <input type="checkbox"/> No </td> <td style="width: 75%;"> <b>Rear wing</b> </td> </tr> </table> | | <b>Additions</b> | <input checked="checked" type="checkbox"/> Yes<br><input type="checkbox"/> No | <b>Rear wing</b> |
| <b>Additions</b> | <input checked="checked" type="checkbox"/> Yes<br><input type="checkbox"/> No | <b>Rear wing</b> | | |

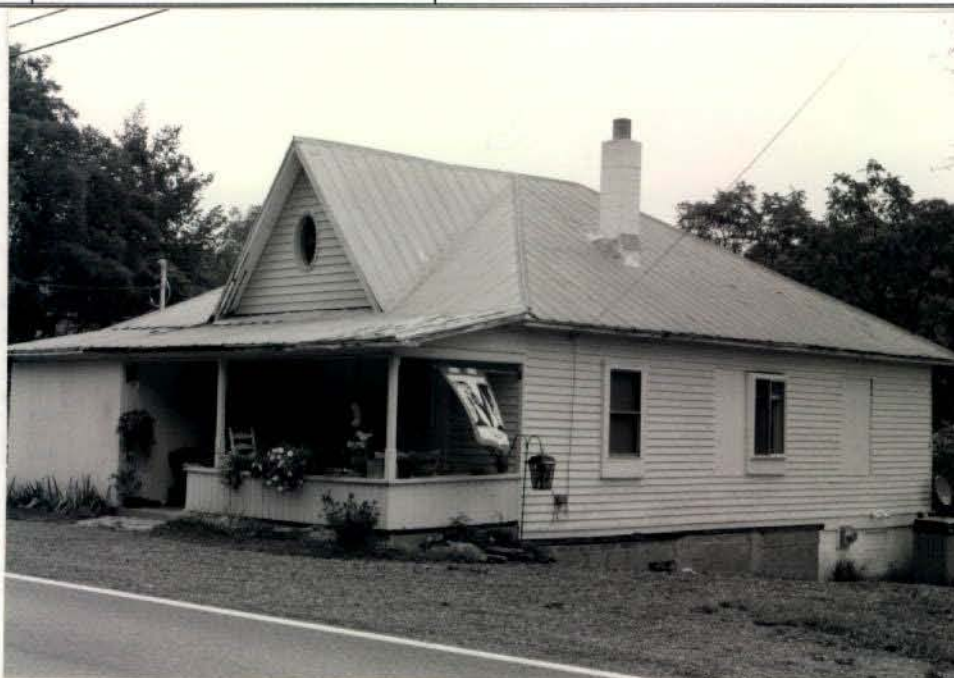
| <b>Description of Buildings or Site (Original and Present)</b> <div style="float: right; text-align: right;"> 1 Stories      1 Front Bays </div> <p>This structure was built in the Craftsman style. It has a simple hipped roof with a cross cable dormer that has a bulls eye window. The windows are double hung with wooden sills. There is a slope placed chimney that is a stove pipe incased in cinder blocks. On the front of the building is a porch that has an extended roof.</p> | |
| <b>Alterations</b> <input checked="" type="checkbox"/> Yes <input type="checkbox"/> No    If yes, describe<br><p>The addition of vinyl siding and more modern roofing materials. One third of the front porch has been inclosed with plywood and painted over.</p> | |
