## WEST VIRGINIA HISTORIC PROPERTY INVENTORY FORM

| <b>Address</b><br>Fox Hollow Road and Rt. 50 | <b>Common/Historic Name/Both</b><br>x            O            O<br>The Berg | <b>Field Survey #</b><br>HM-1246 | <b>Site # (SHPO Only)</b><br>see also HM-0043 |

| <b>Street Address</b><br>Off US 50, at the base<br>of Mill Creek Mtn. | <b>Common/Historic Name/Both</b><br><input type="radio"/> <input checked="" type="radio"/> <input type="radio"/><br>Isaac Means House | <b>Field Survey #</b> | <b>Site # (SHPO Only)</b><br>HM-0043 |

CORRIDOR "H" FIELD REVIEW PROJECT

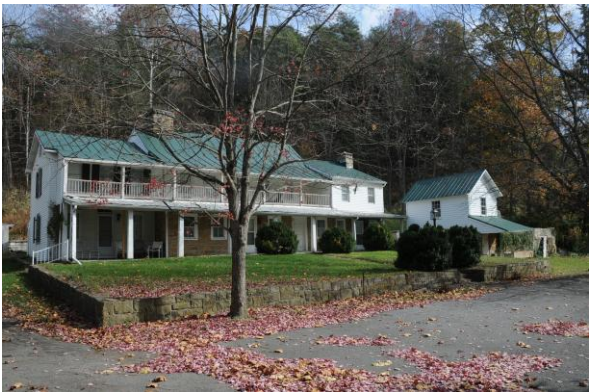
| <b>Describe Setting</b><br>Tree shaded lot at the intersection of Fox Hollow Road and Rt 50. Well kept aspect, stone retaining wall in front of the lawn<br><br><div style="text-align: right;"> _____ Acres<br/><br/> _____ Artifacts Present </div> | | | | | |
| <b>Description of Building or Site (Original and Present)</b> <div style="float: right; text-align: right;"> <b>2    Stories    _____ Front Bays</b> </div> Standing seam metal roof extends over second floor gallery, shed roofed porch extends over lower level supported by 8 tapering square wood pillars. Two/2 double hung sash. Three paneled wood doors on first floor. Left side extension is somewhat younger than the main house, with large stone chimney on the gable end. Working shutters, some replacement sash in the extension<br><br><i>(Use Continuation Sheets)</i> | | | | | |
| <b>Describe All Outbuildings</b><br>One stone and wood spring house with new siding and roof, C, one block double garage (NC)<br><br><div style="text-align: right;"><i>(Use Continuation Sheets)</i></div> | | | | | |

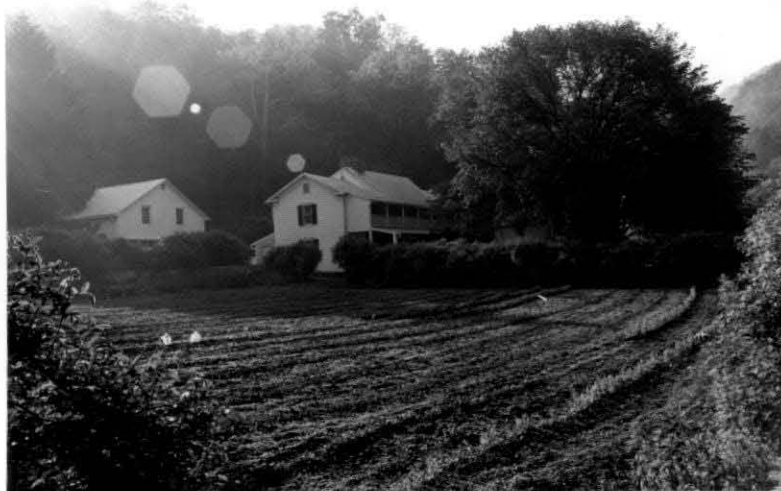
FRAME (Pt log?) Hsc w/  
NAME Hm- Stone Chimney

| | PHYSICAL DESCRIPTION<br>(include photograph if possible) | This two-story frame house is rather unusual in shape. There is a main rectangular section with a steep gable roof at one end of which projects a large stone chimney. To each side of this is a section with a gable roof of much lower pitch; there is a chimney at the end of only one of these units. A double porch is across the entire front. |
| | STATEMENT OF SIGNIFICANCE | Based on the physical structure: the unusual, though symmetrical, placement of a steep-gabled center rectangle flanked by smaller units is pleasing. The large stone interior end chimney in the main section may indicate quite early construction. The full length double porch is picturesque. |
